Technical Report No. 26

**A Methodology for Mapping Current and Historical  
Coverage of Estuarine Vegetation with Aerial  
Photography and ArcView**

**Suzanne Shull  
and  
Douglas A. Bulhuis**

**December 2002**

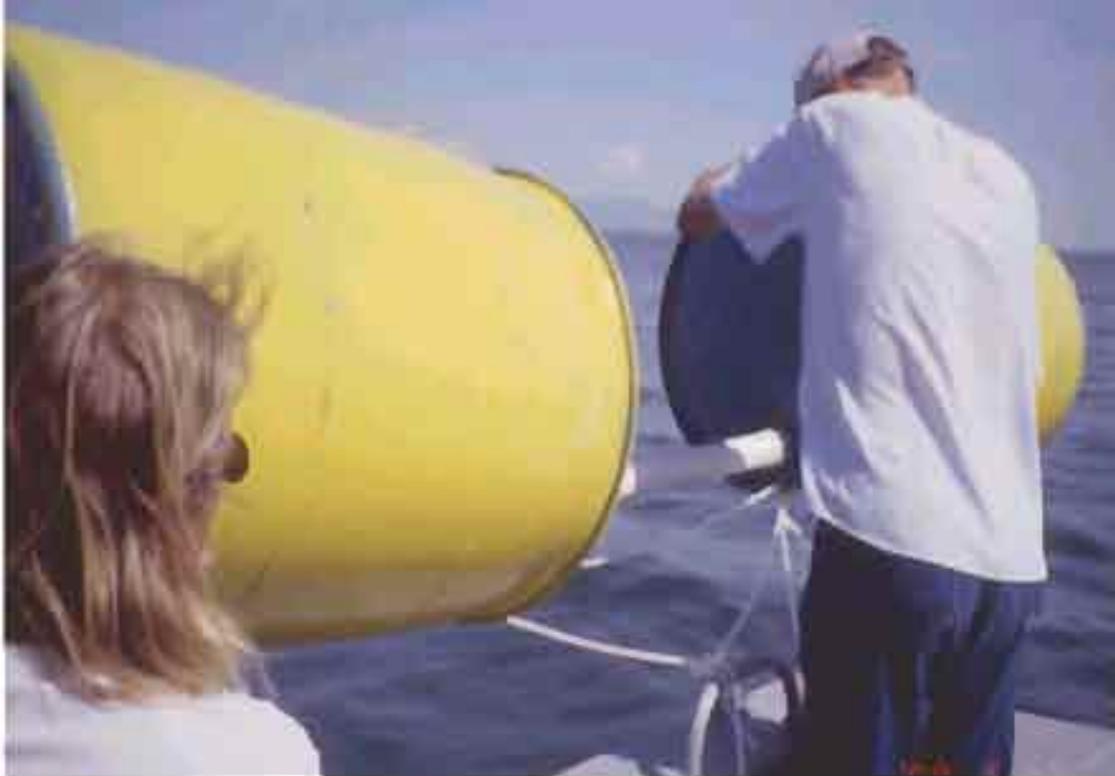
**Figure 2. Control markers built from plastic barrels and PVC pipe used to establish georeference control in Padilla Bay, Washington.**

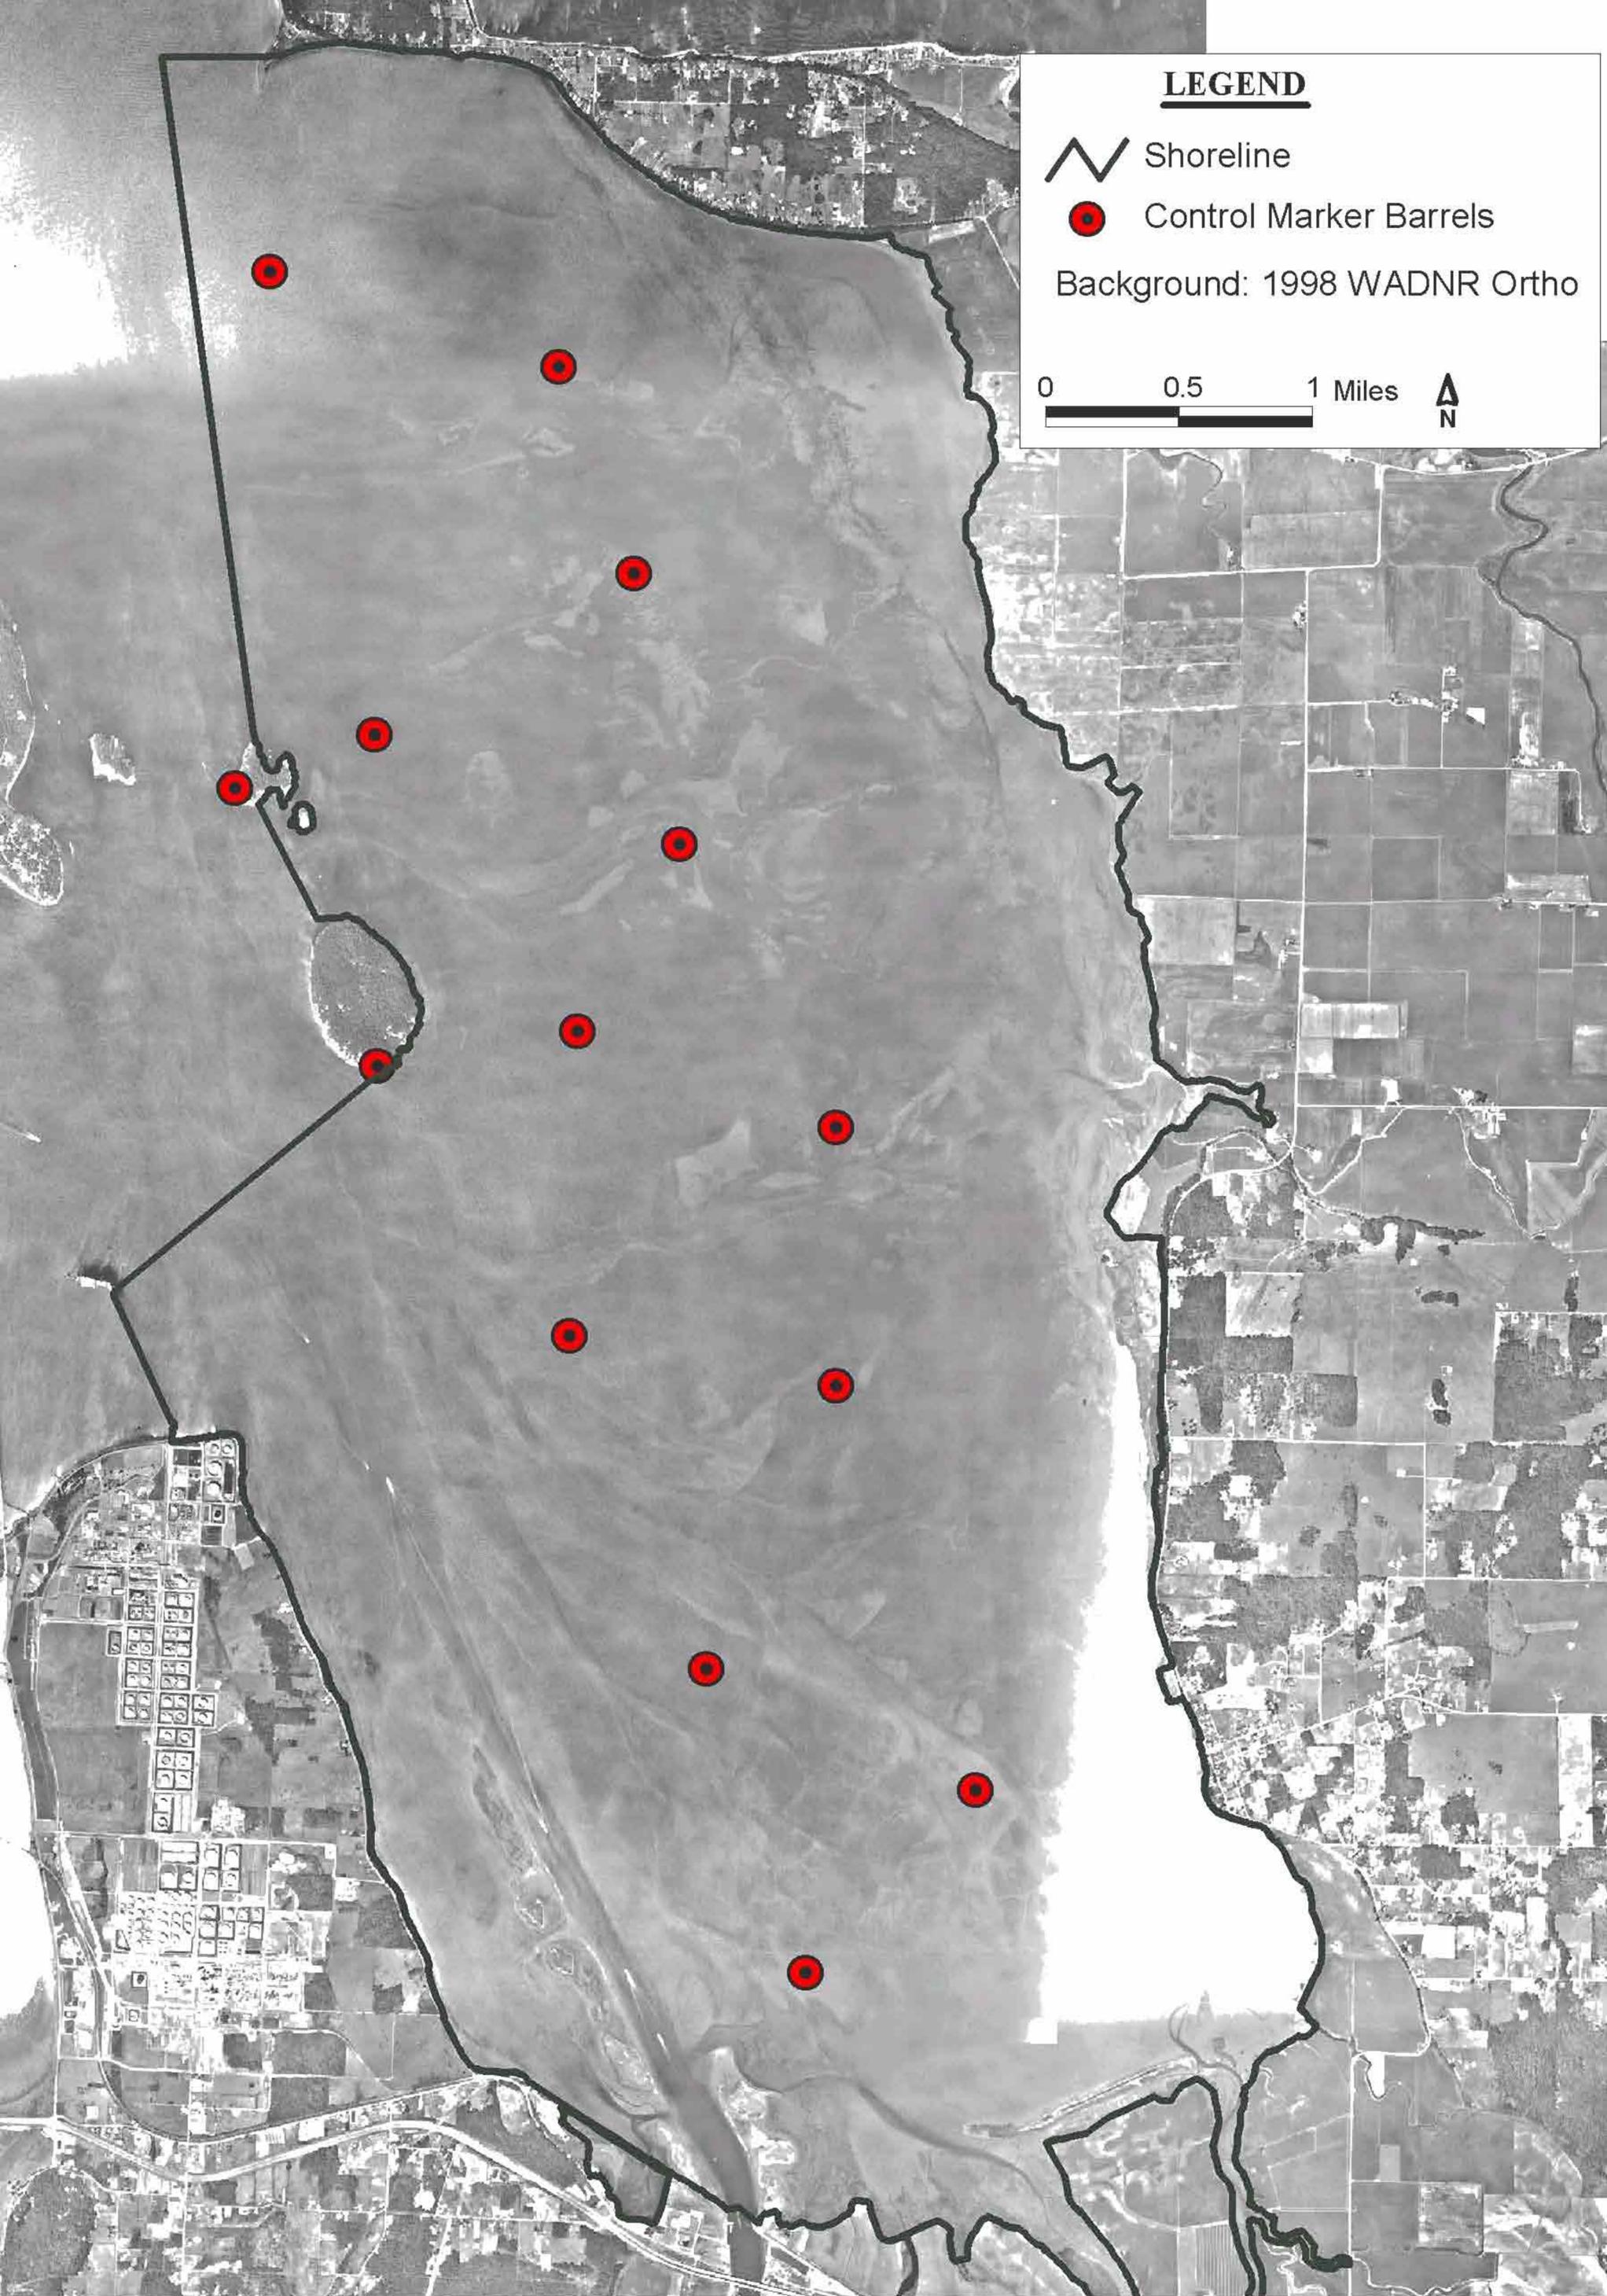
**Figure 3. Control marker barrels overlaid on the 1998 black and white reference image from WADNR of Padilla Bay, Washington.**

Because the reference imagery was in black and white and not acquired on an extreme low tide there were no features in the open bay area to use as control points. Therefore, it was necessary to create our own control features located in the intertidal area of the bay that would be visible in the true color aerial photos. Based on preliminary trials conducted in 1999 (testing the visibility of various shapes in aerial photos in the intertidal areas of Padilla Bay) ground control markers were constructed with two 55-gallon plastic drums joined with PVC piping and deployed as in-bay markers before the time of flyover (Figure 2). Marker designs that were tested, but subsequently rejected were an 8' plywood sheet painted white and two 12'x 8" beams crossed to form an X. The barrel markers were more easily detected in the 1:42000 scale imagery because of their 3-dimensional shape. Twelve of the barrel markers were constructed and deployed on June 27 and 28, 2000 on high tide throughout Padilla Bay in areas where shoreline and landmarks would not be visible on the low altitude aerial photos (Figure 3).

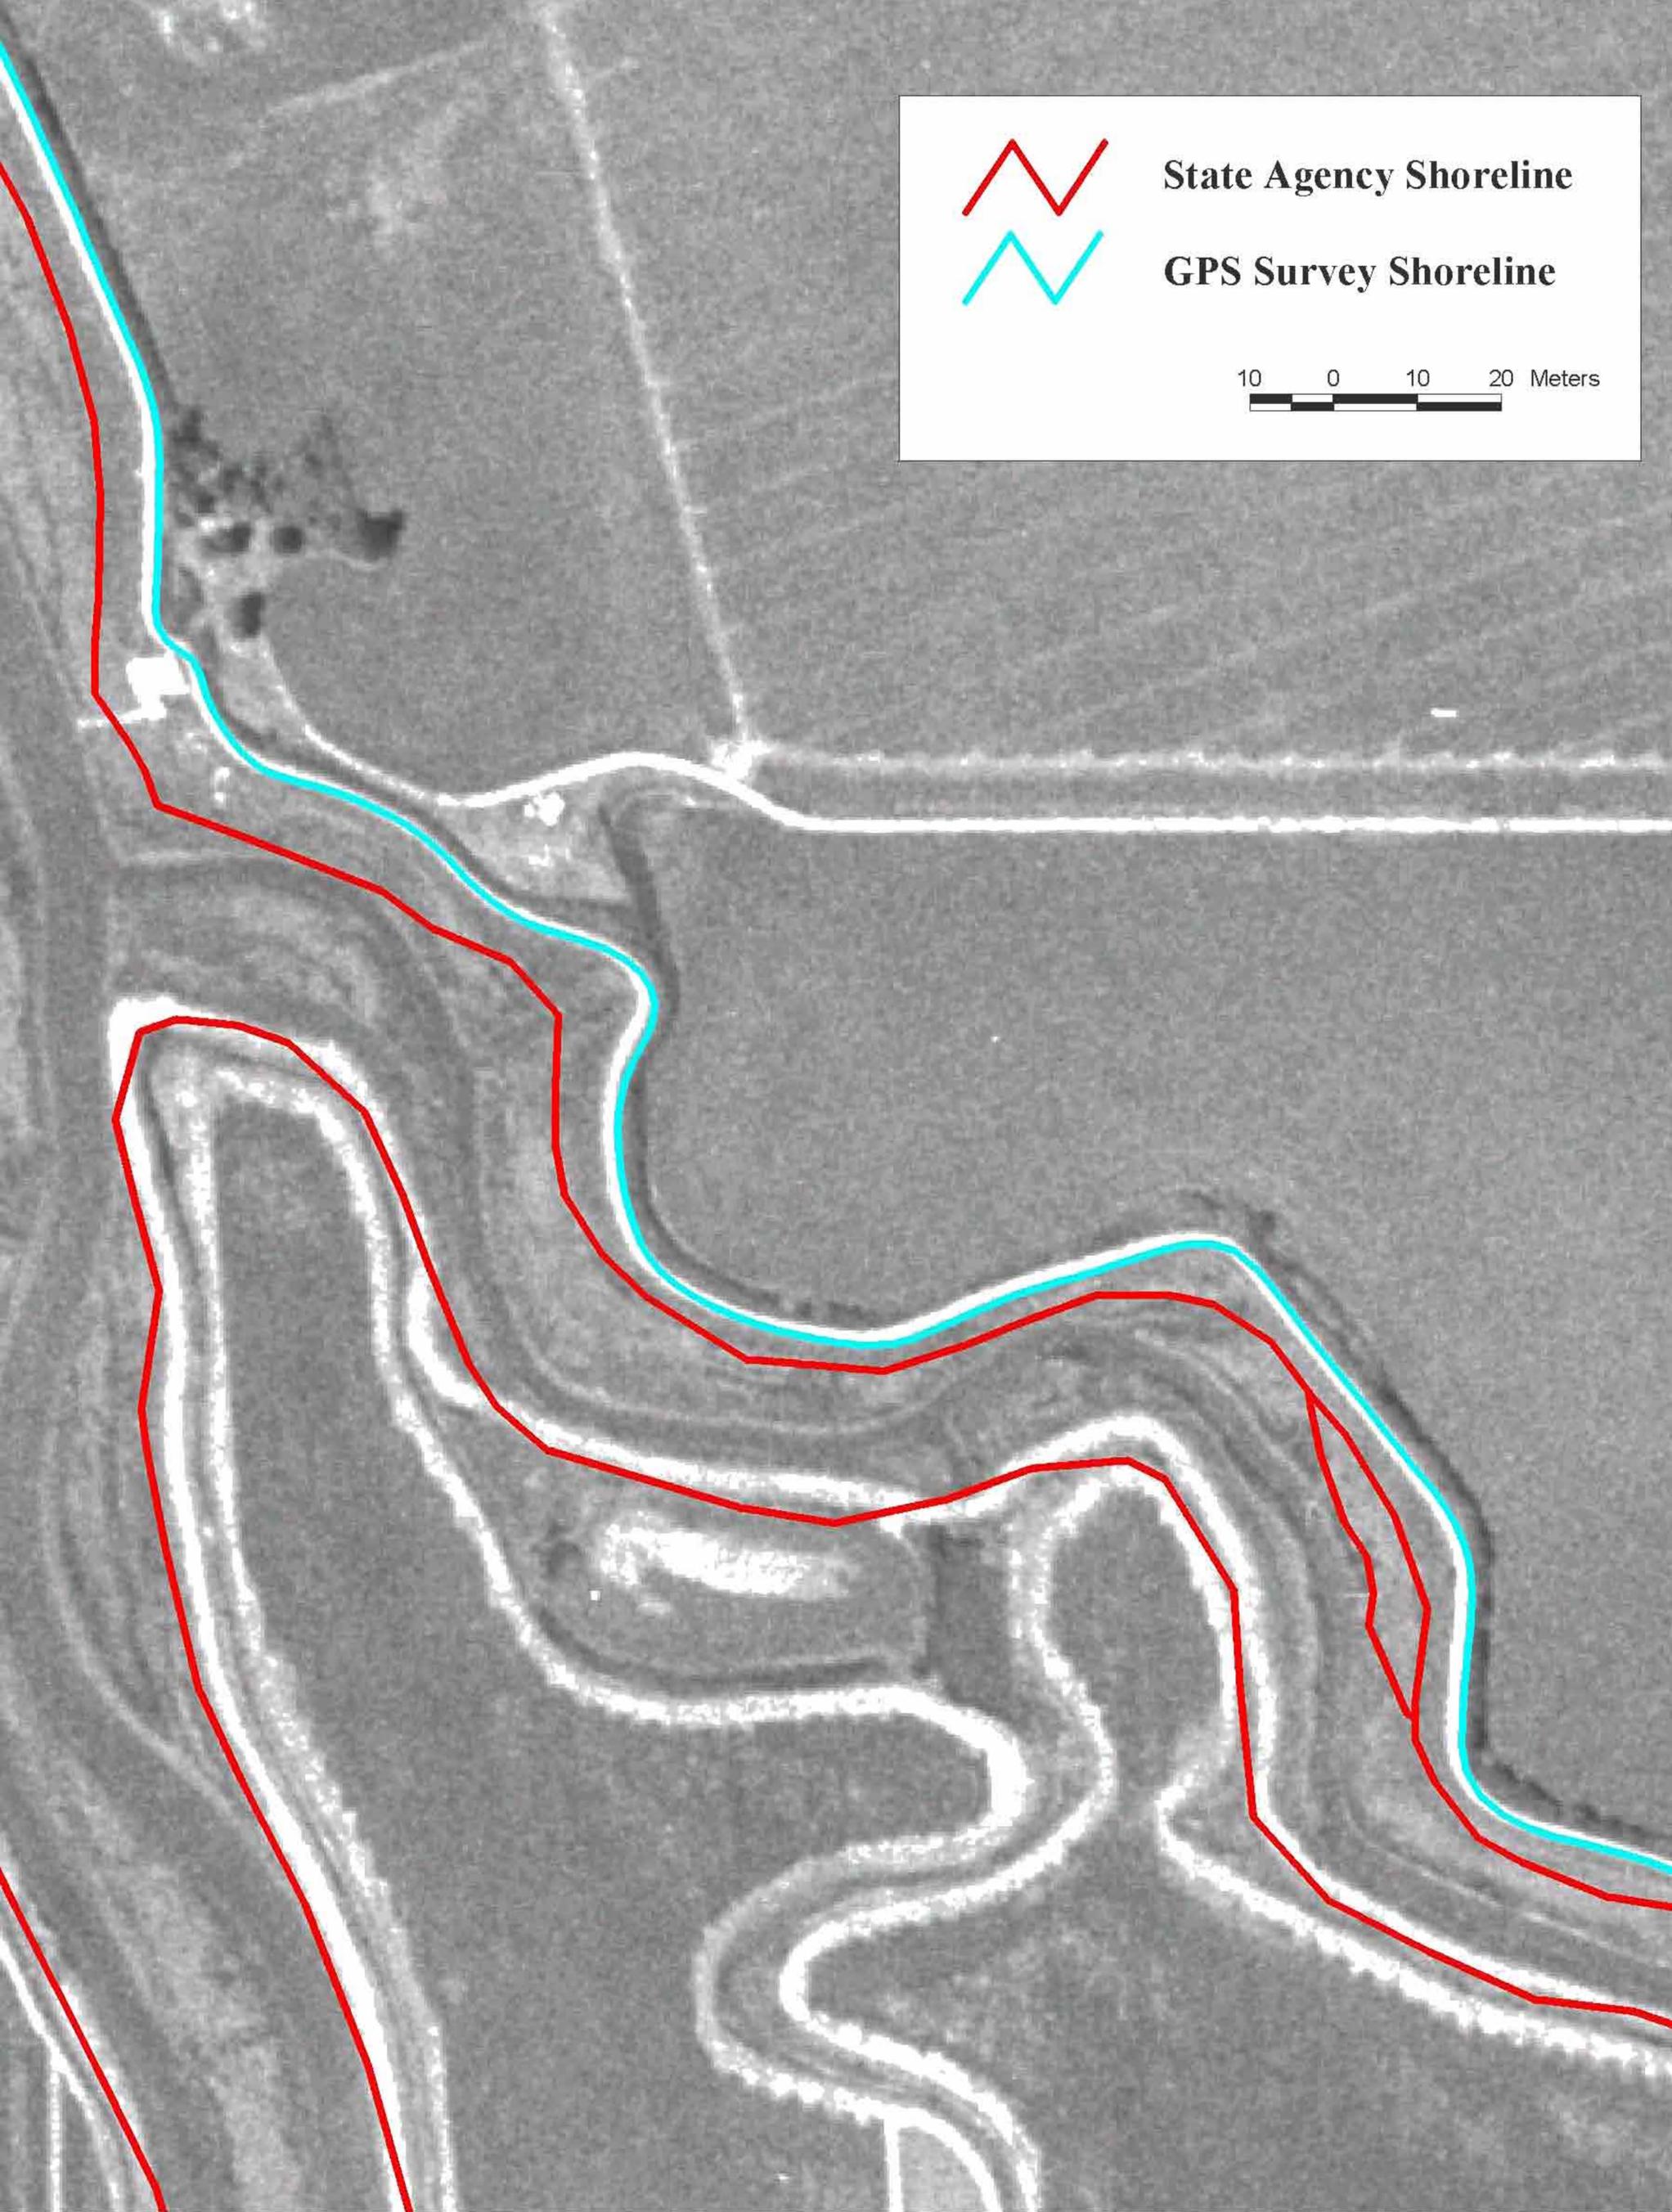
**Figure 5. State agency shoreline and survey grade GPS shoreline displayed on 1998 orthophotograph. Note the lack of alignment between the state agency shoreline and the orthorectified reference image.**

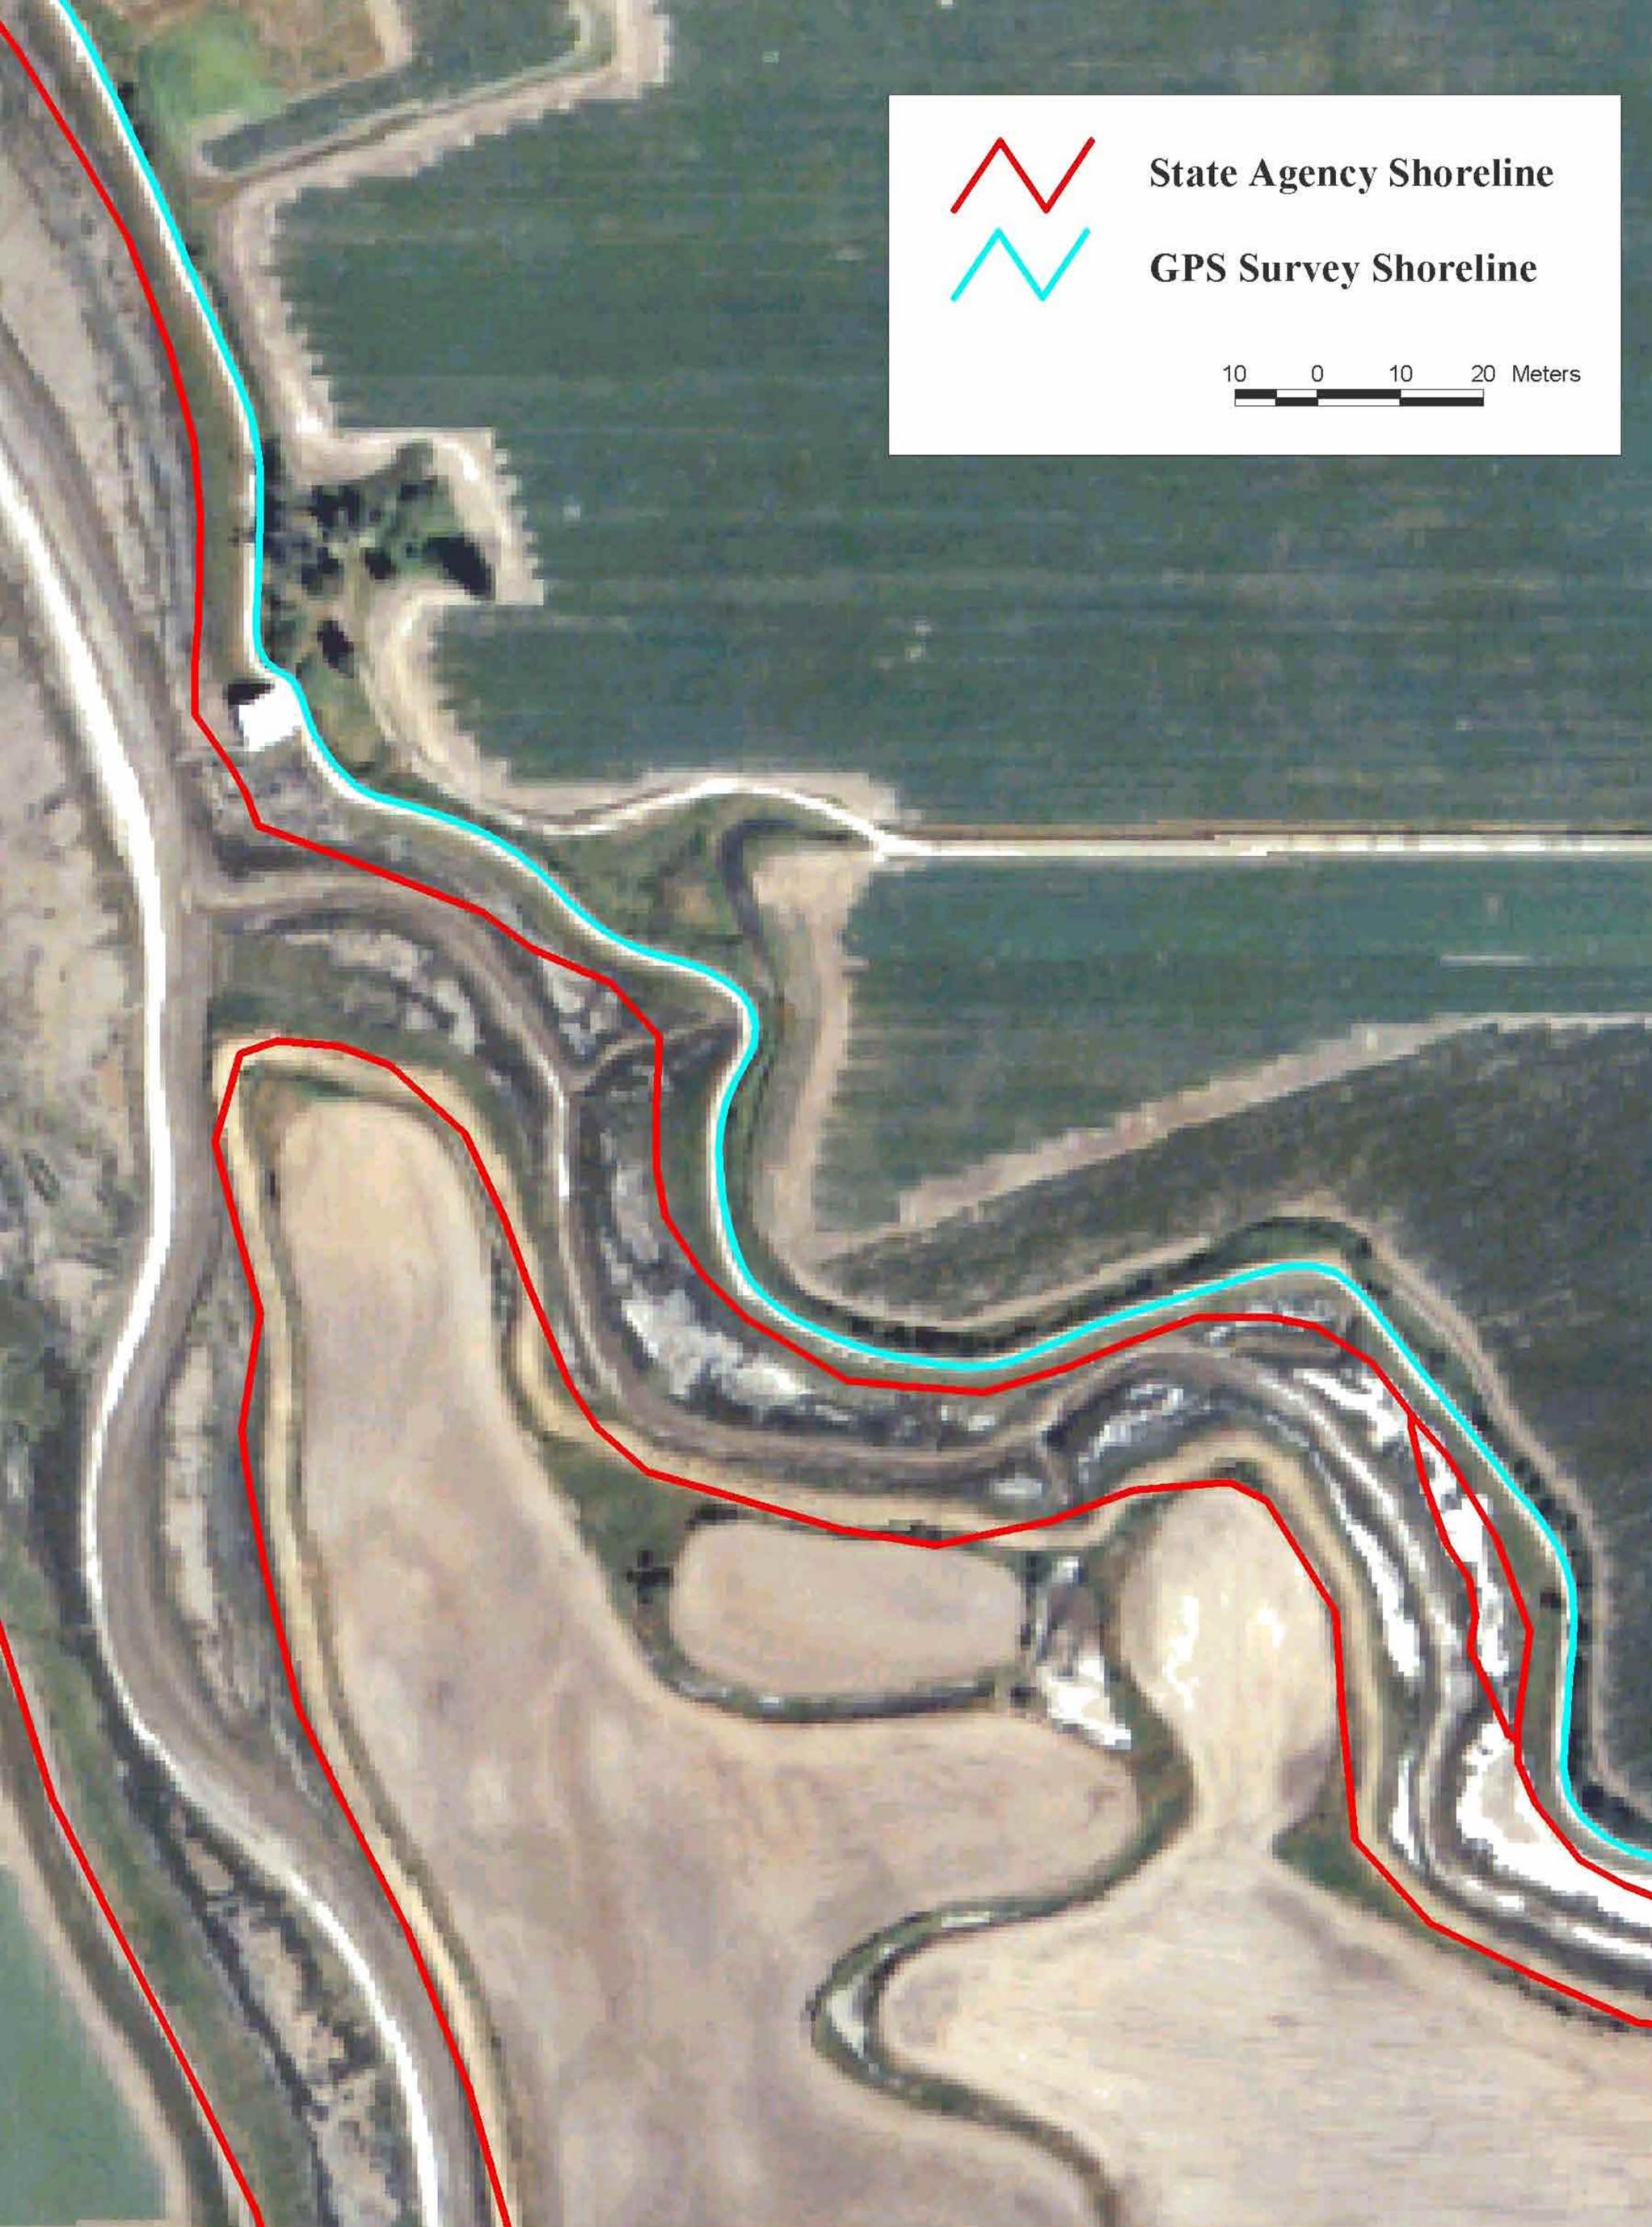
**Figure 6. State agency shoreline and survey grade GPS shoreline displayed on a 2000 aerial photo that has been georectified. Note the positional accuracy of the georectified photograph, and the lack of alignment between the state agency shoreline and the GPS shoreline.**

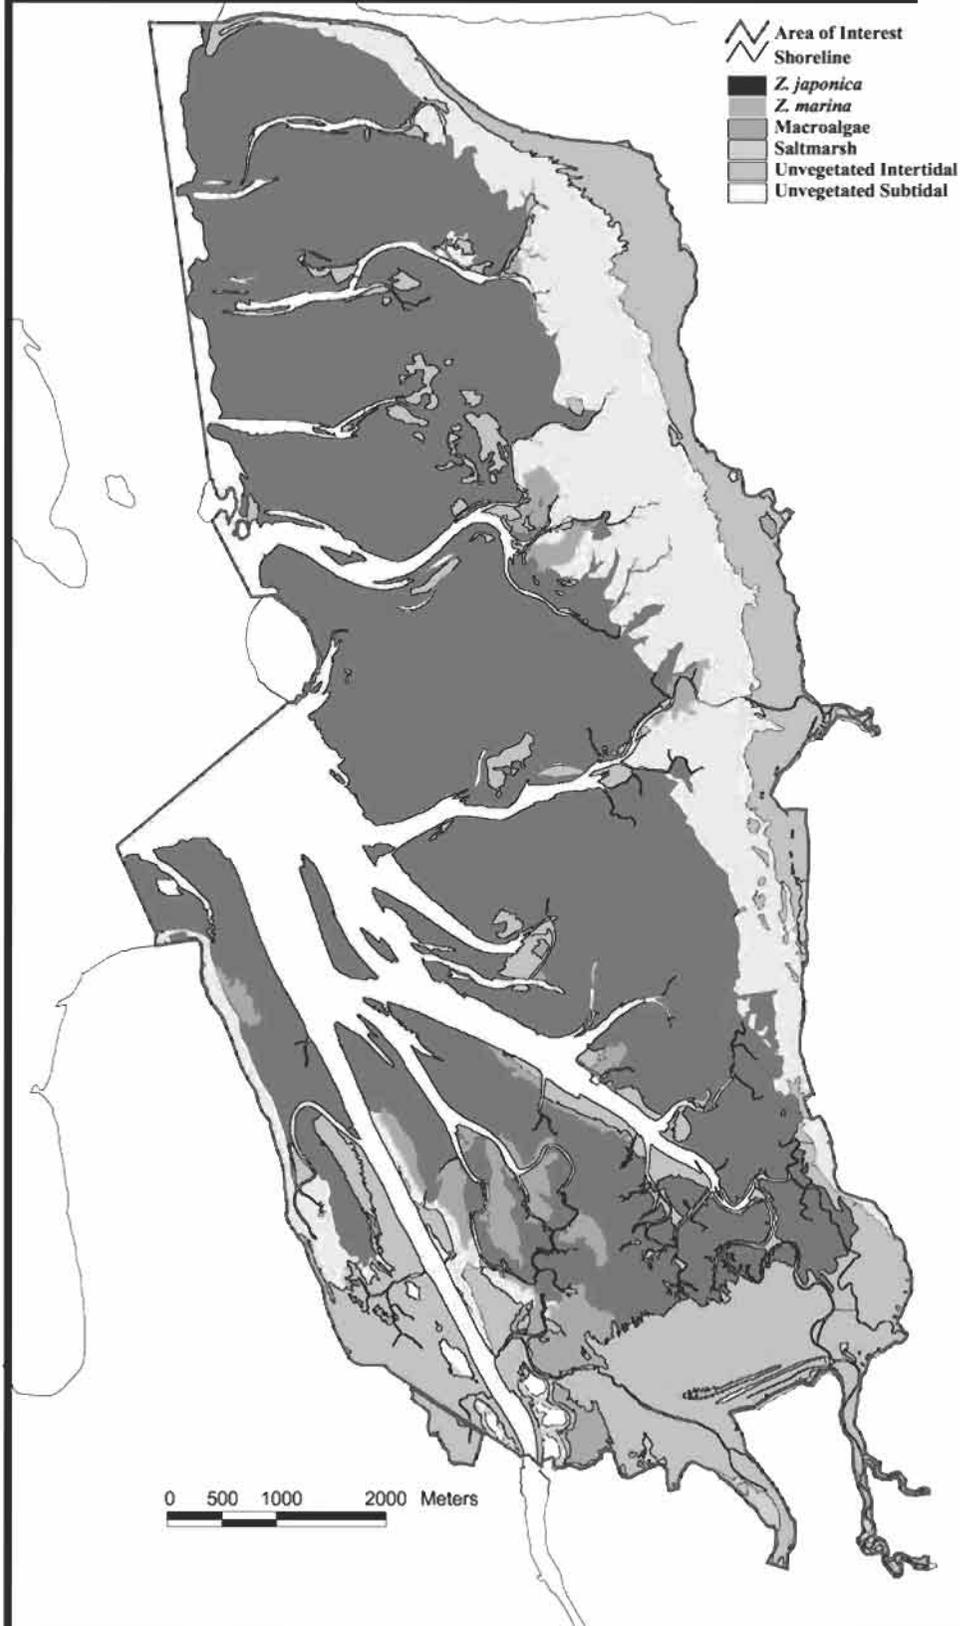
**Figure 8.** Two classes of eelgrass, salt marsh, and macroalgae in Padilla Bay, Washington in 2000 with the delineated cover classes (see Figure 7) combined into four categories.

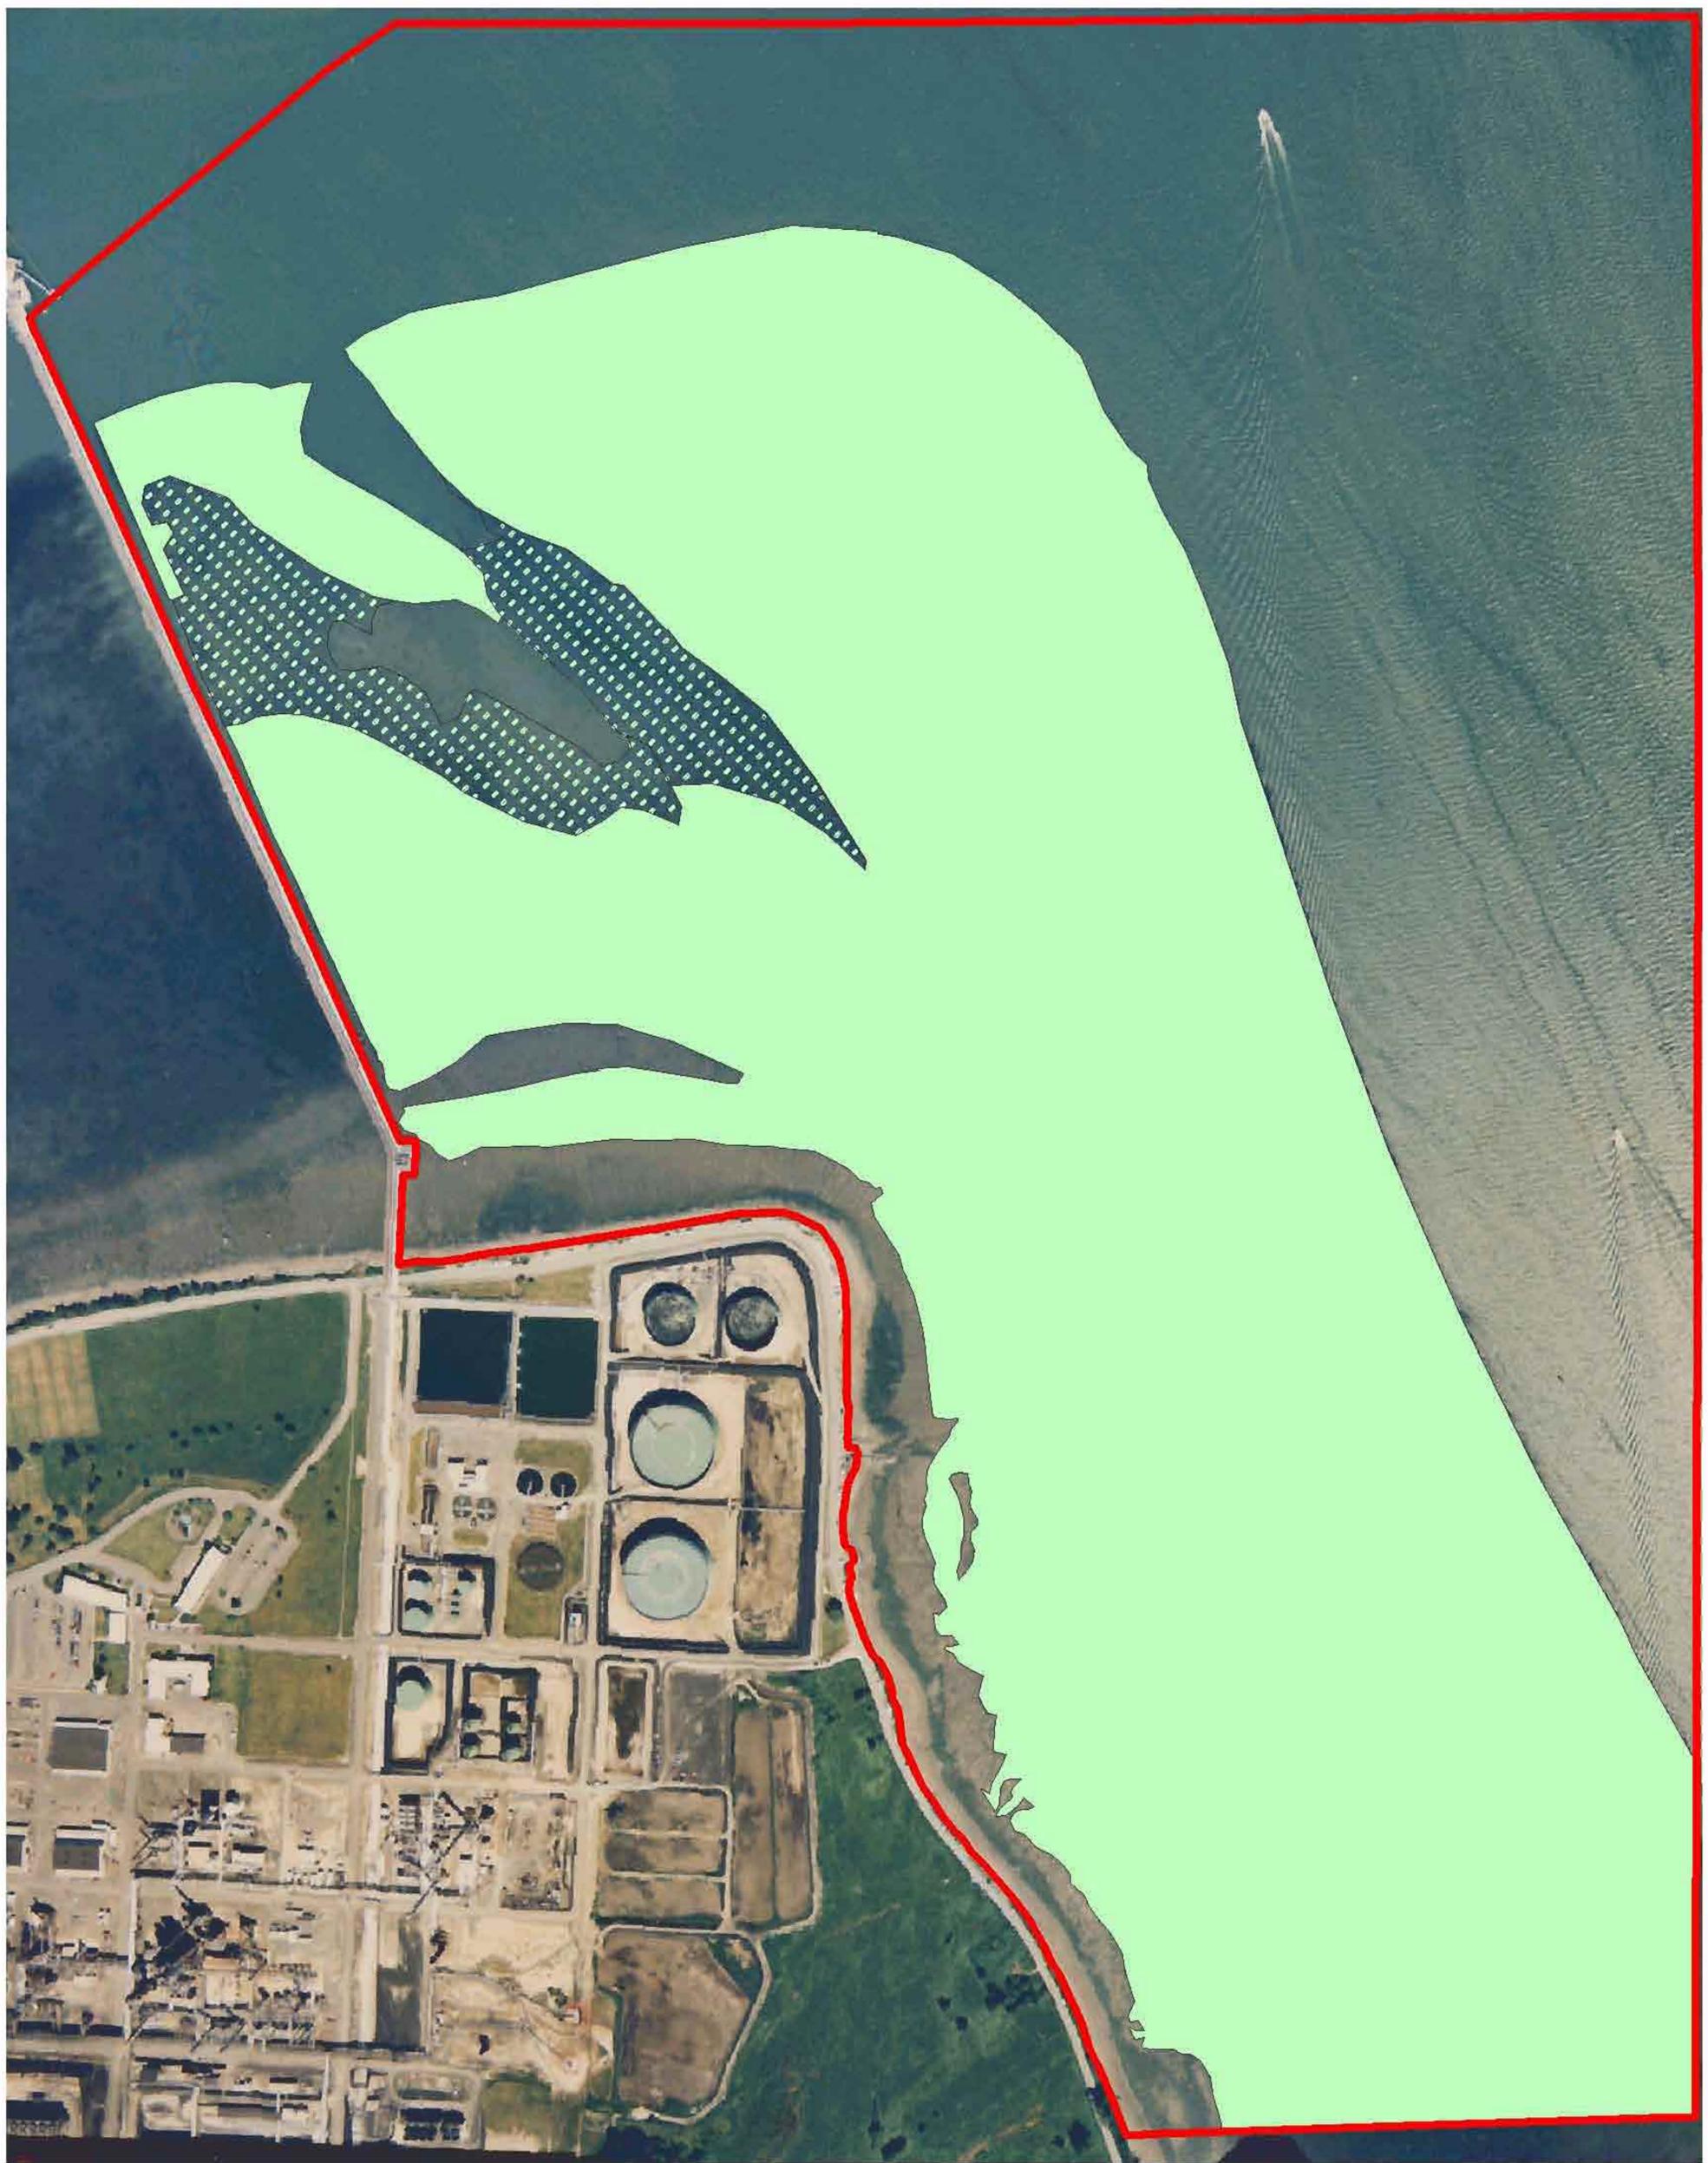
**Figure 9. Continuous eelgrass cover (in solid fill) and sparse eelgrass cover (in stipple pattern) in March Point area of interest in Padilla Bay, Washington as delineated on true color aerial photographs taken on June 3, 1989.**

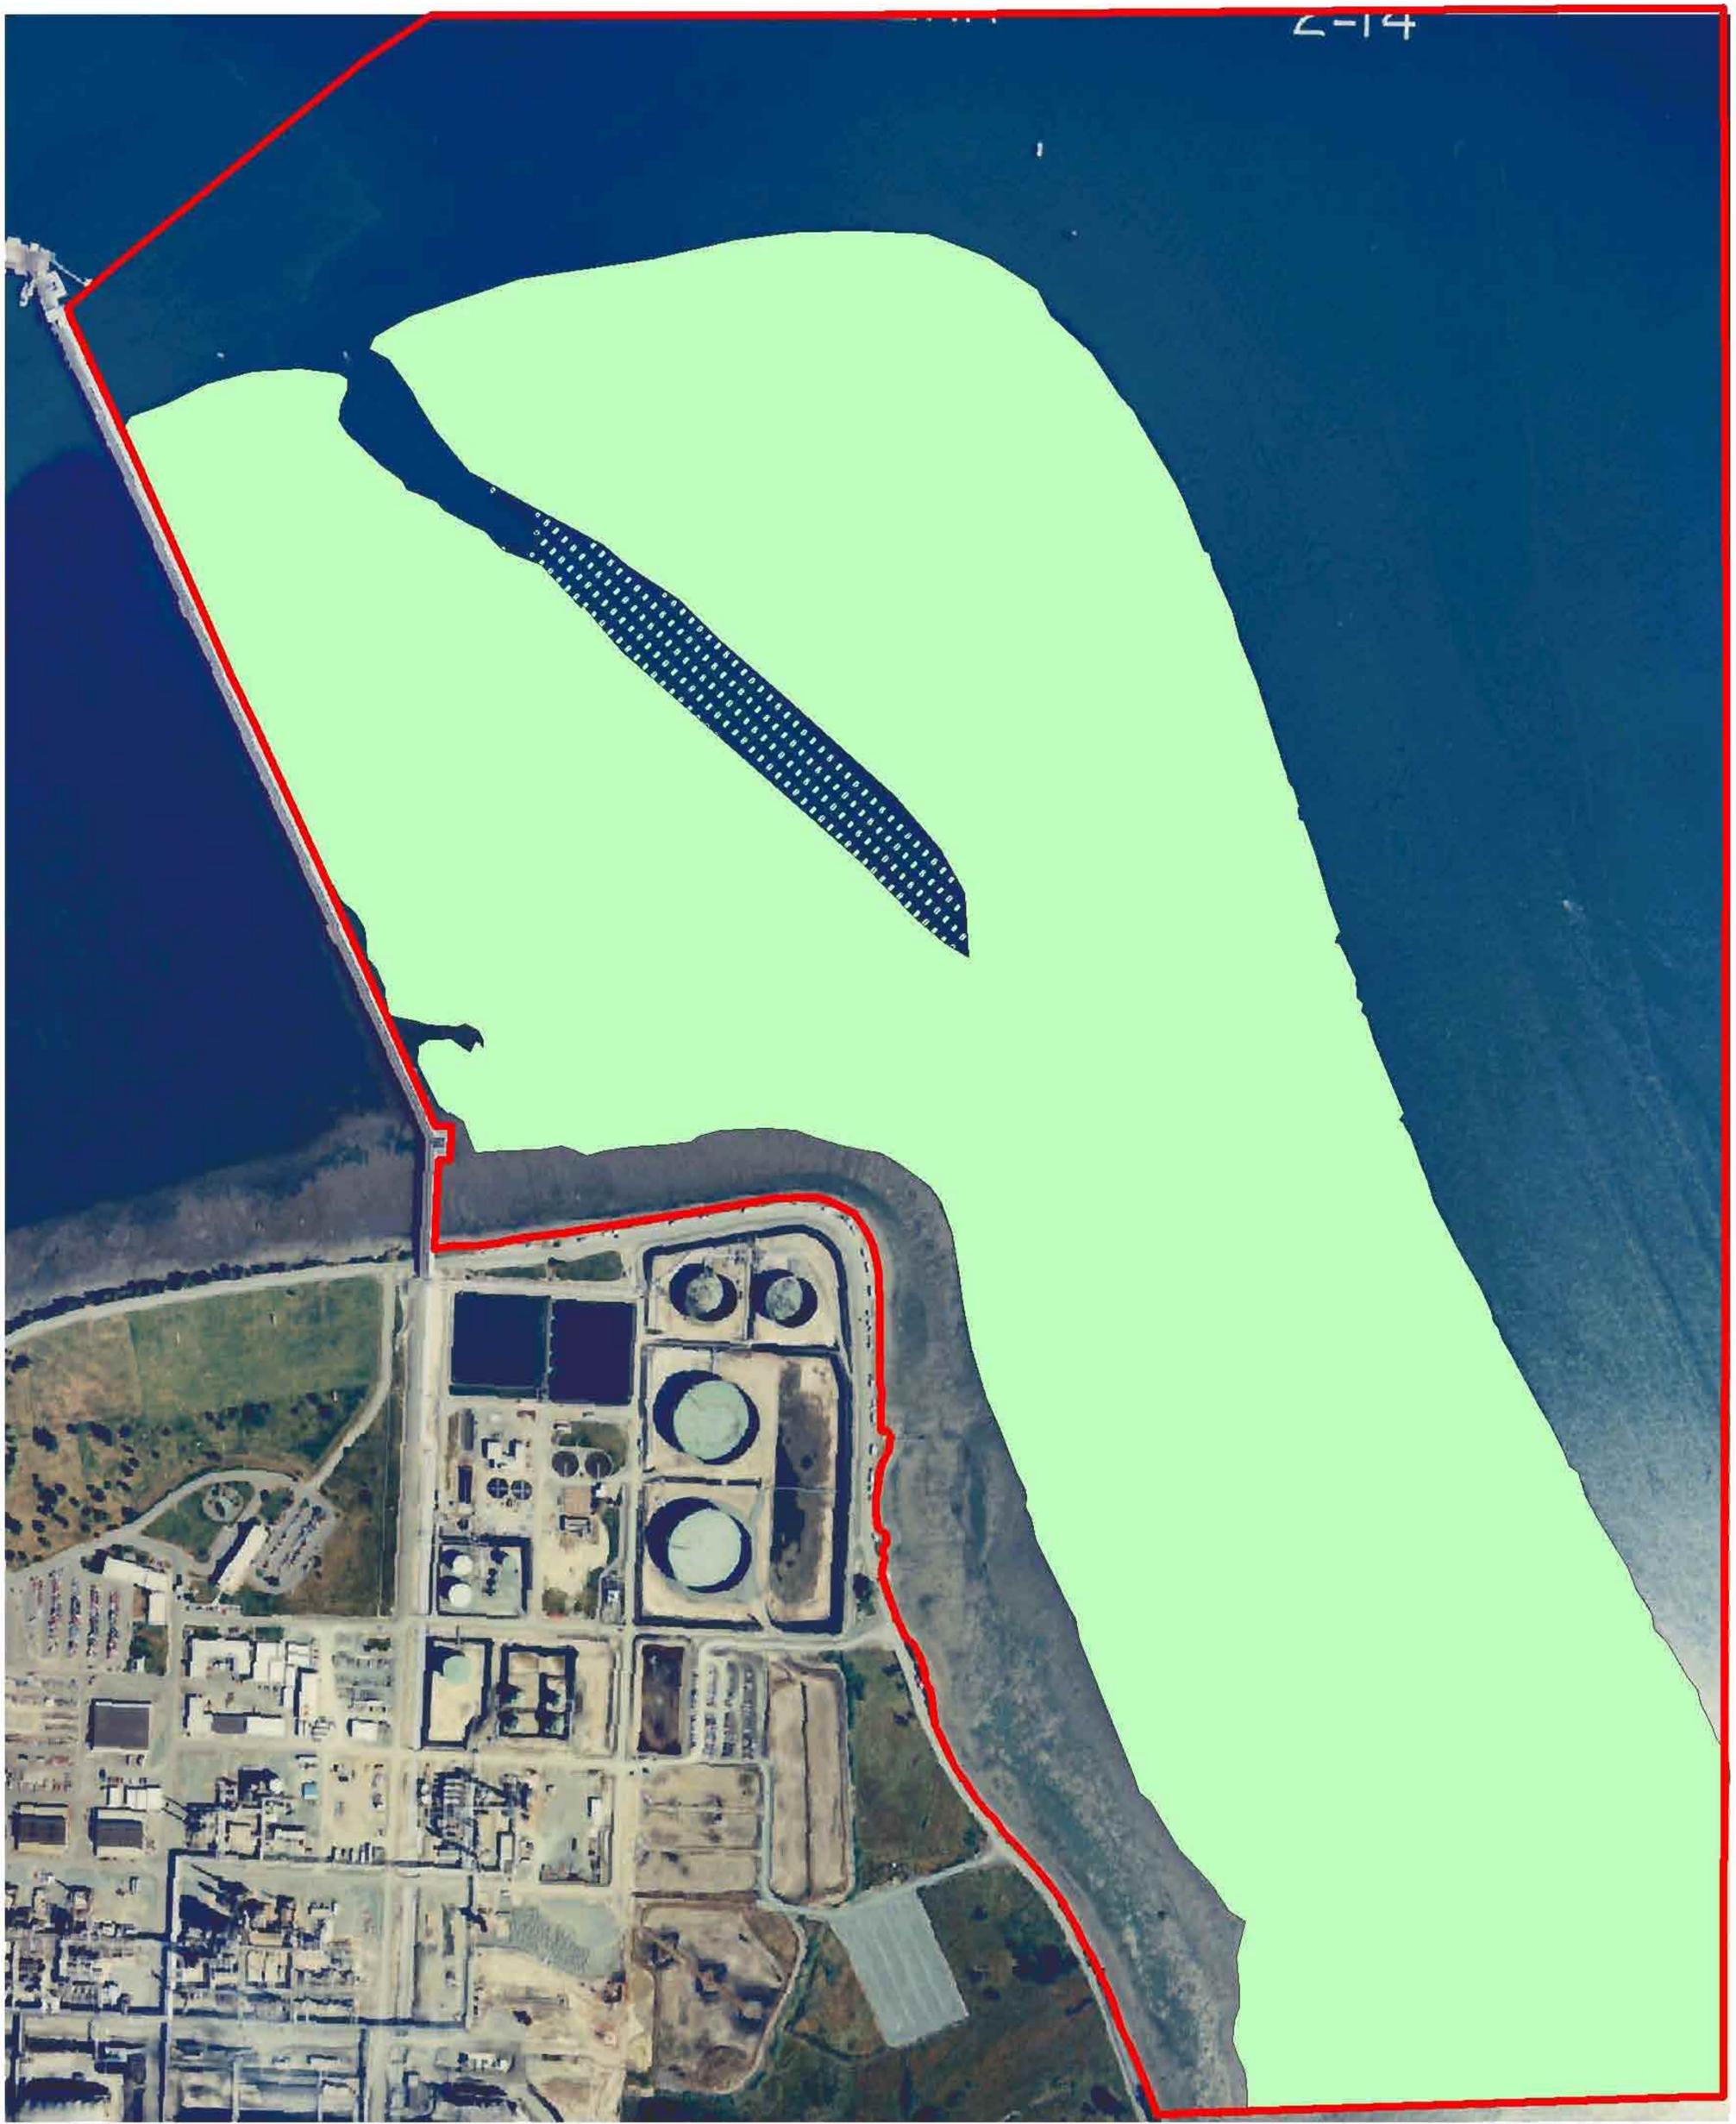
**Figure 10. Continuous eelgrass cover (in solid fill) and sparse eelgrass cover (in stipple pattern) in March Point area of interest in Padilla Bay, Washington as delineated on true color aerial photographs taken on July 28, 1992.**
