Technical Report No. 26

**A Methodology for Mapping Current and Historical  
Coverage of Estuarine Vegetation with Aerial  
Photography and ArcView**

**Suzanne Shull  
and  
Douglas A. Bulhuis**

**December 2002**

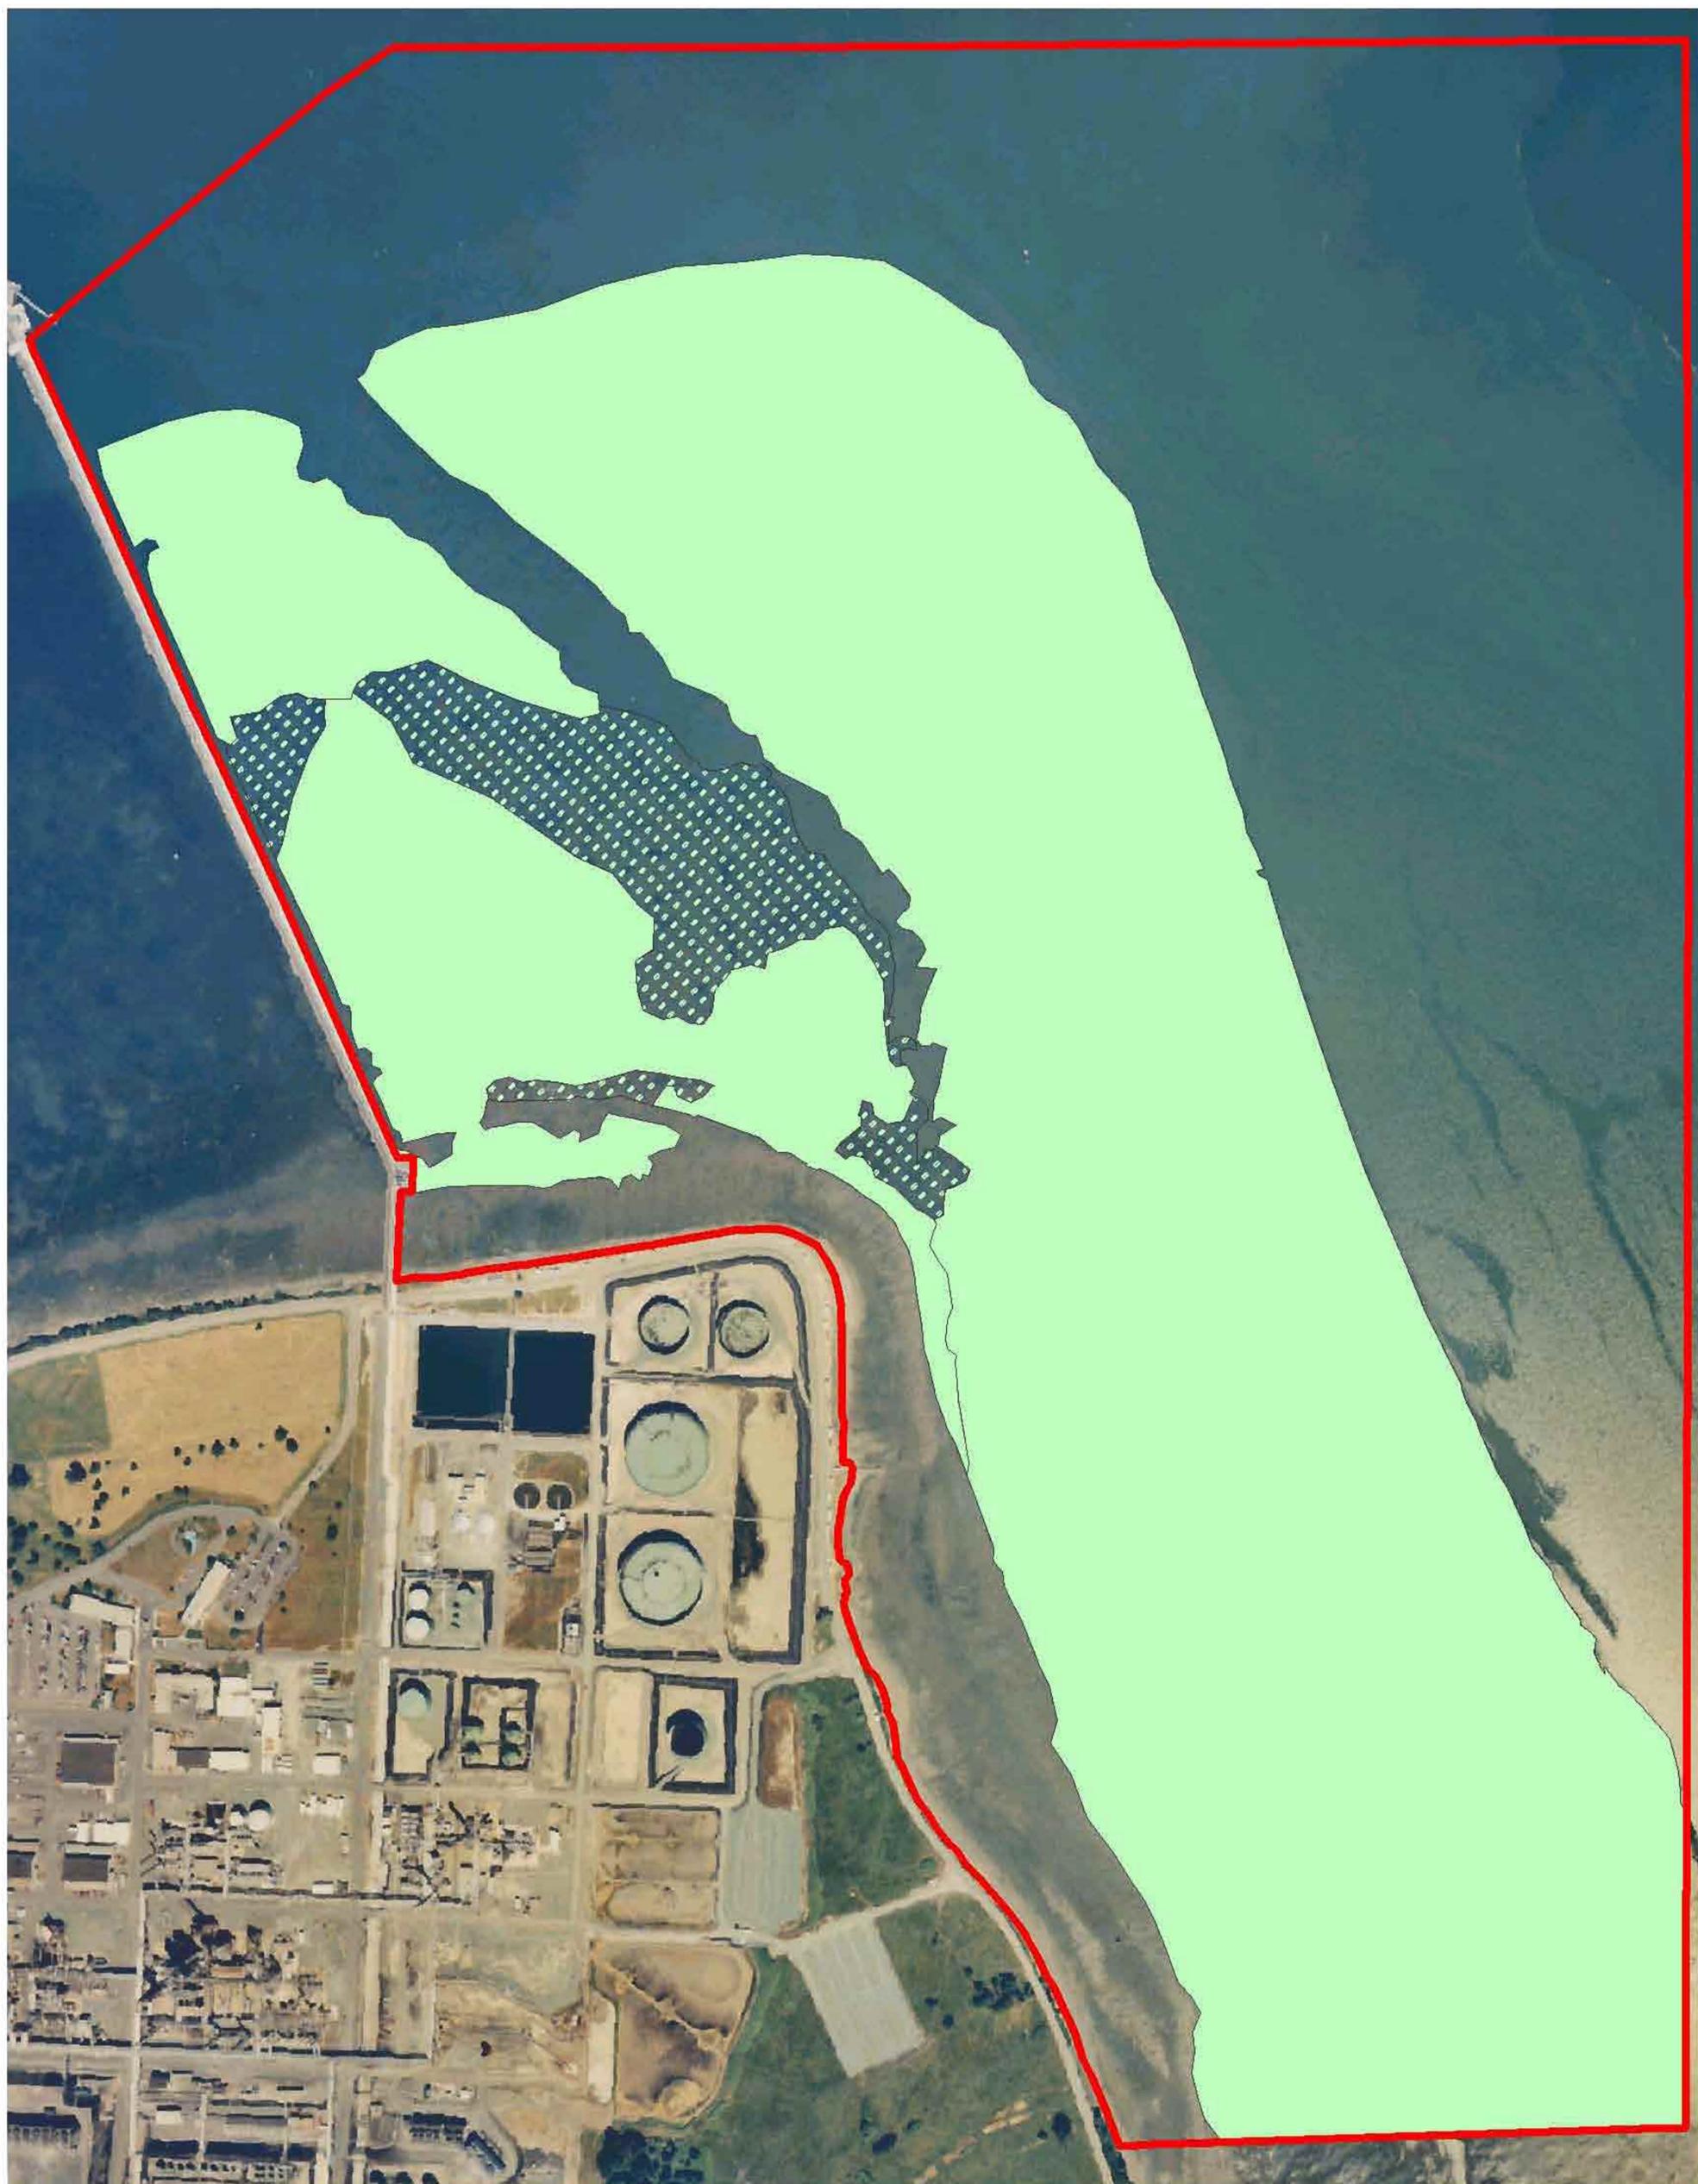
**Figure 11. TContinuous eelgrass cover (in solid fill) and sparse eelgrass cover (in stipple pattern) in March Point area of interest in Padilla Bay, Washington as delineated on true color aerial photographs taken on July 1, 1996.**

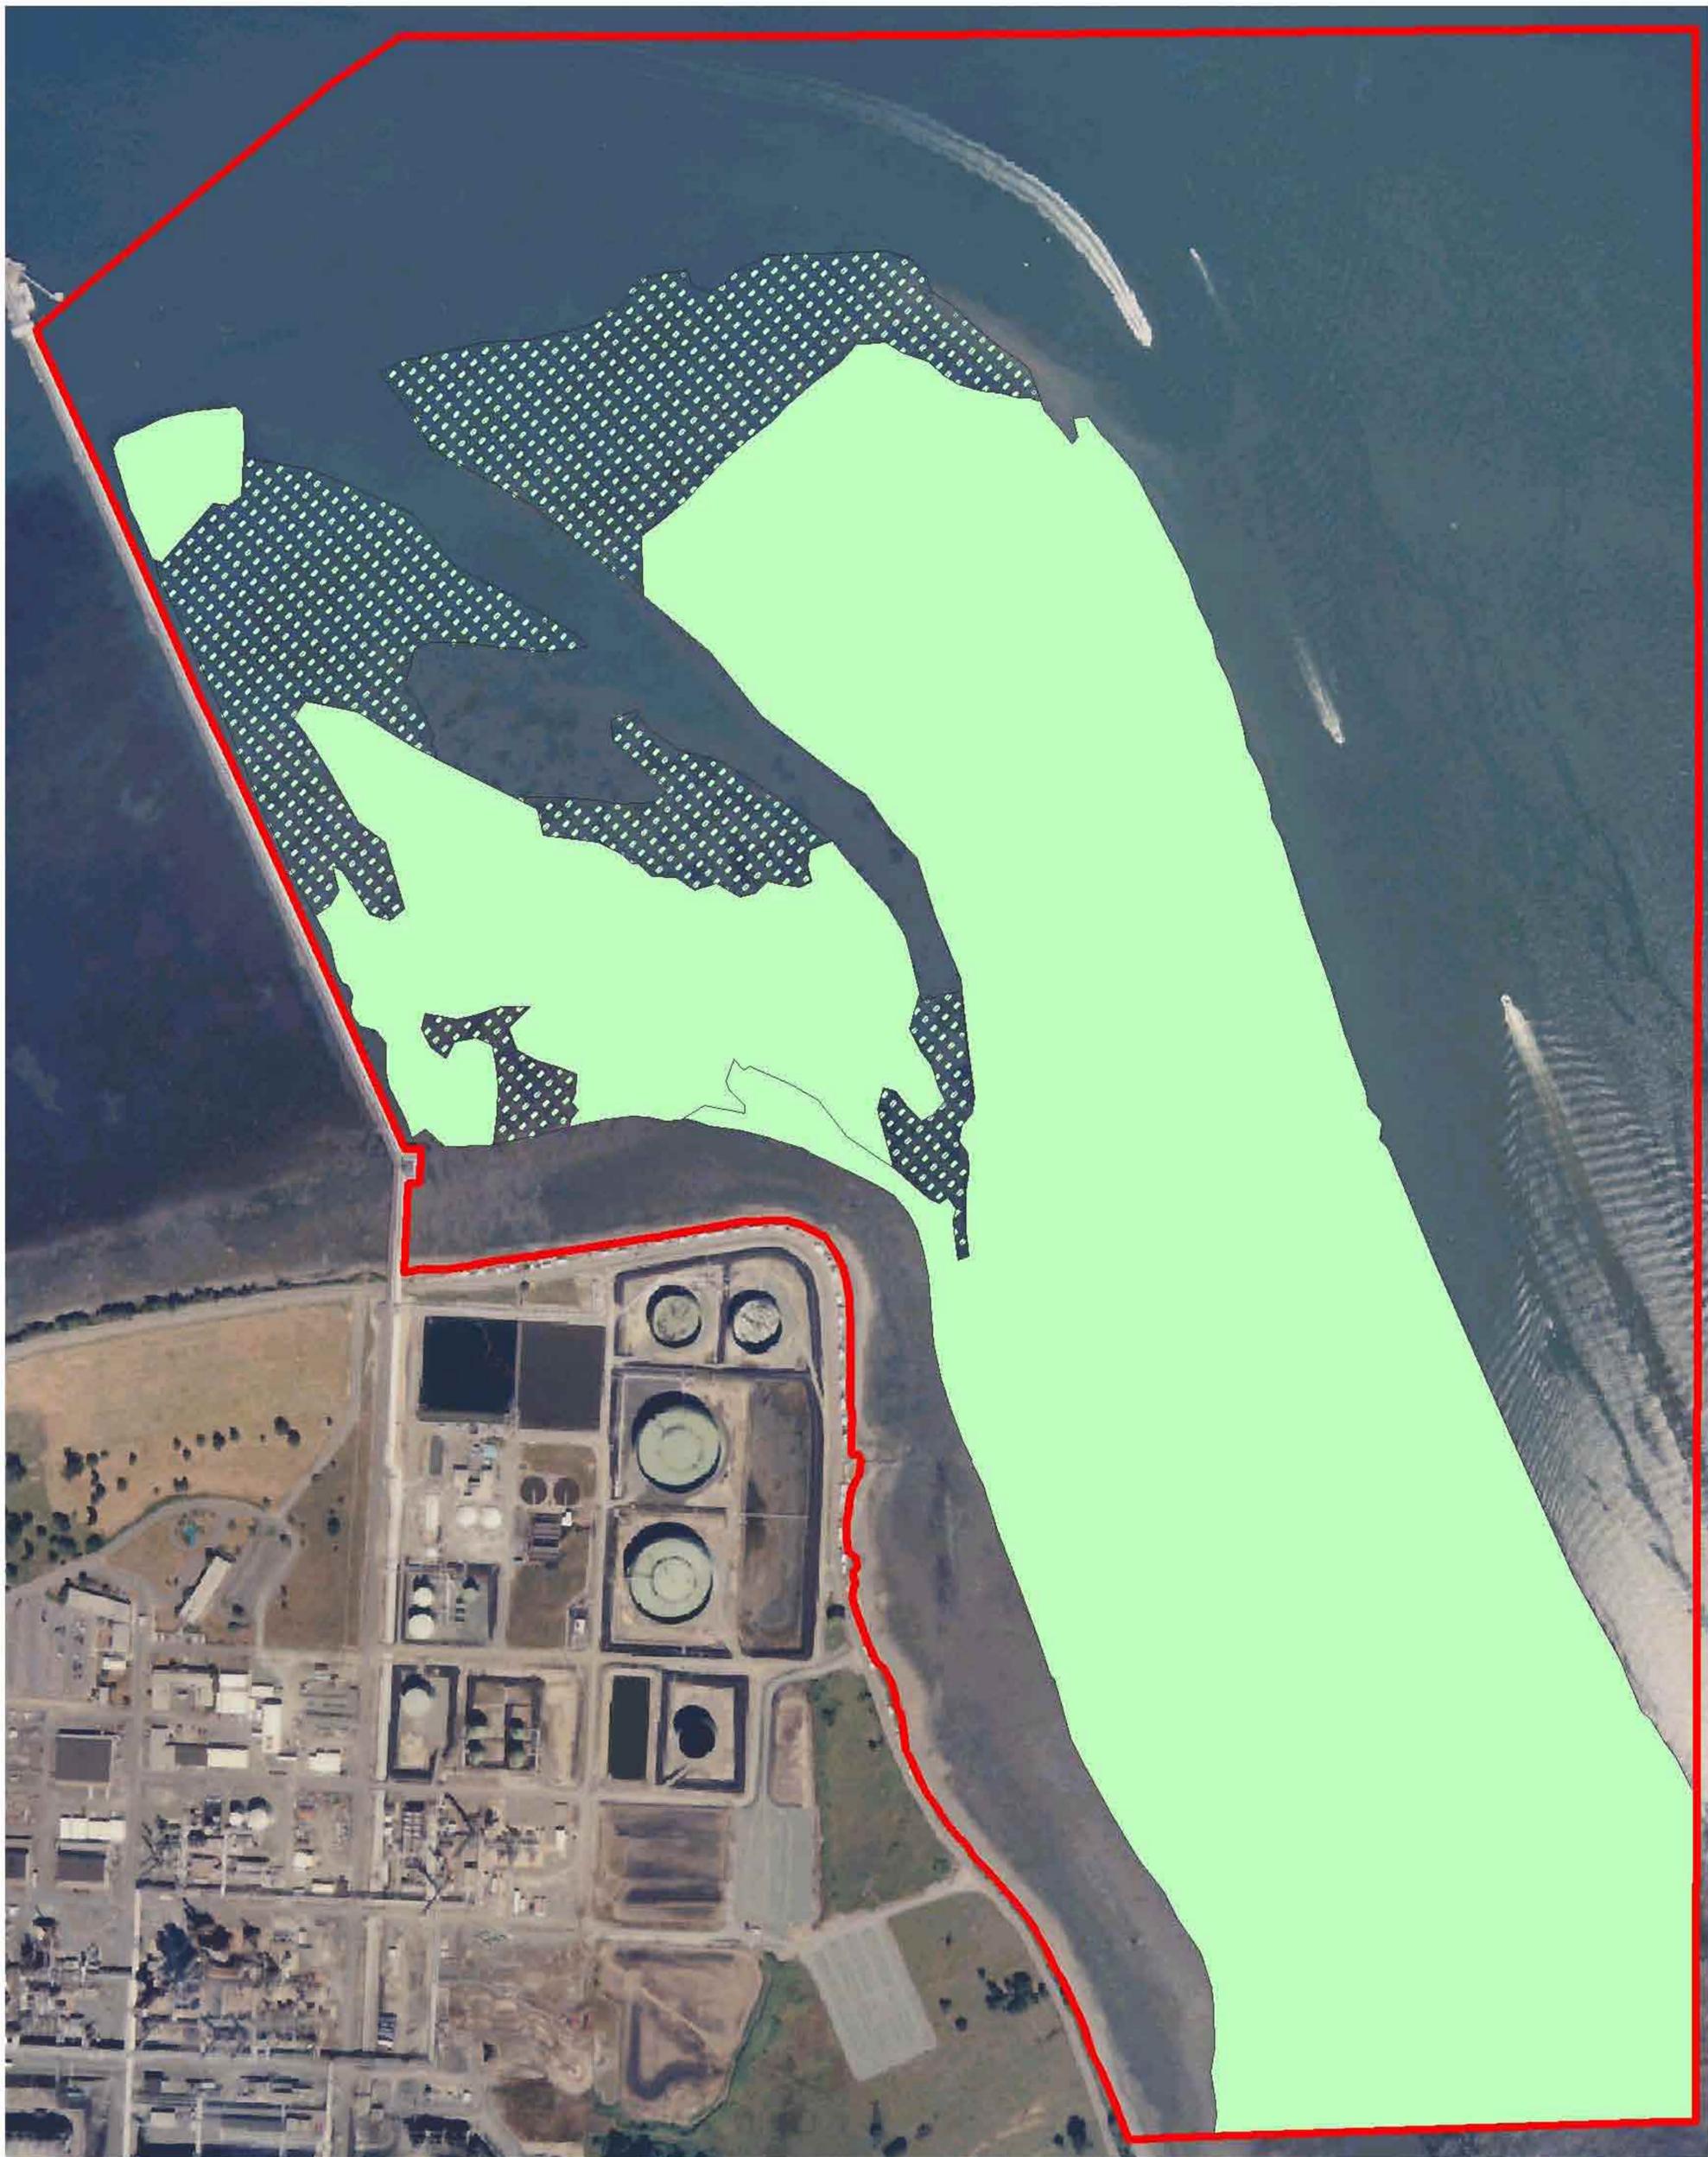
**Figure 12. Continuous eelgrass cover (in solid fill) and sparse eelgrass cover (in stipple pattern) in March Point area of interest in Padilla Bay, Washington as delineated on true color aerial photographs taken on July 30, 2000.**

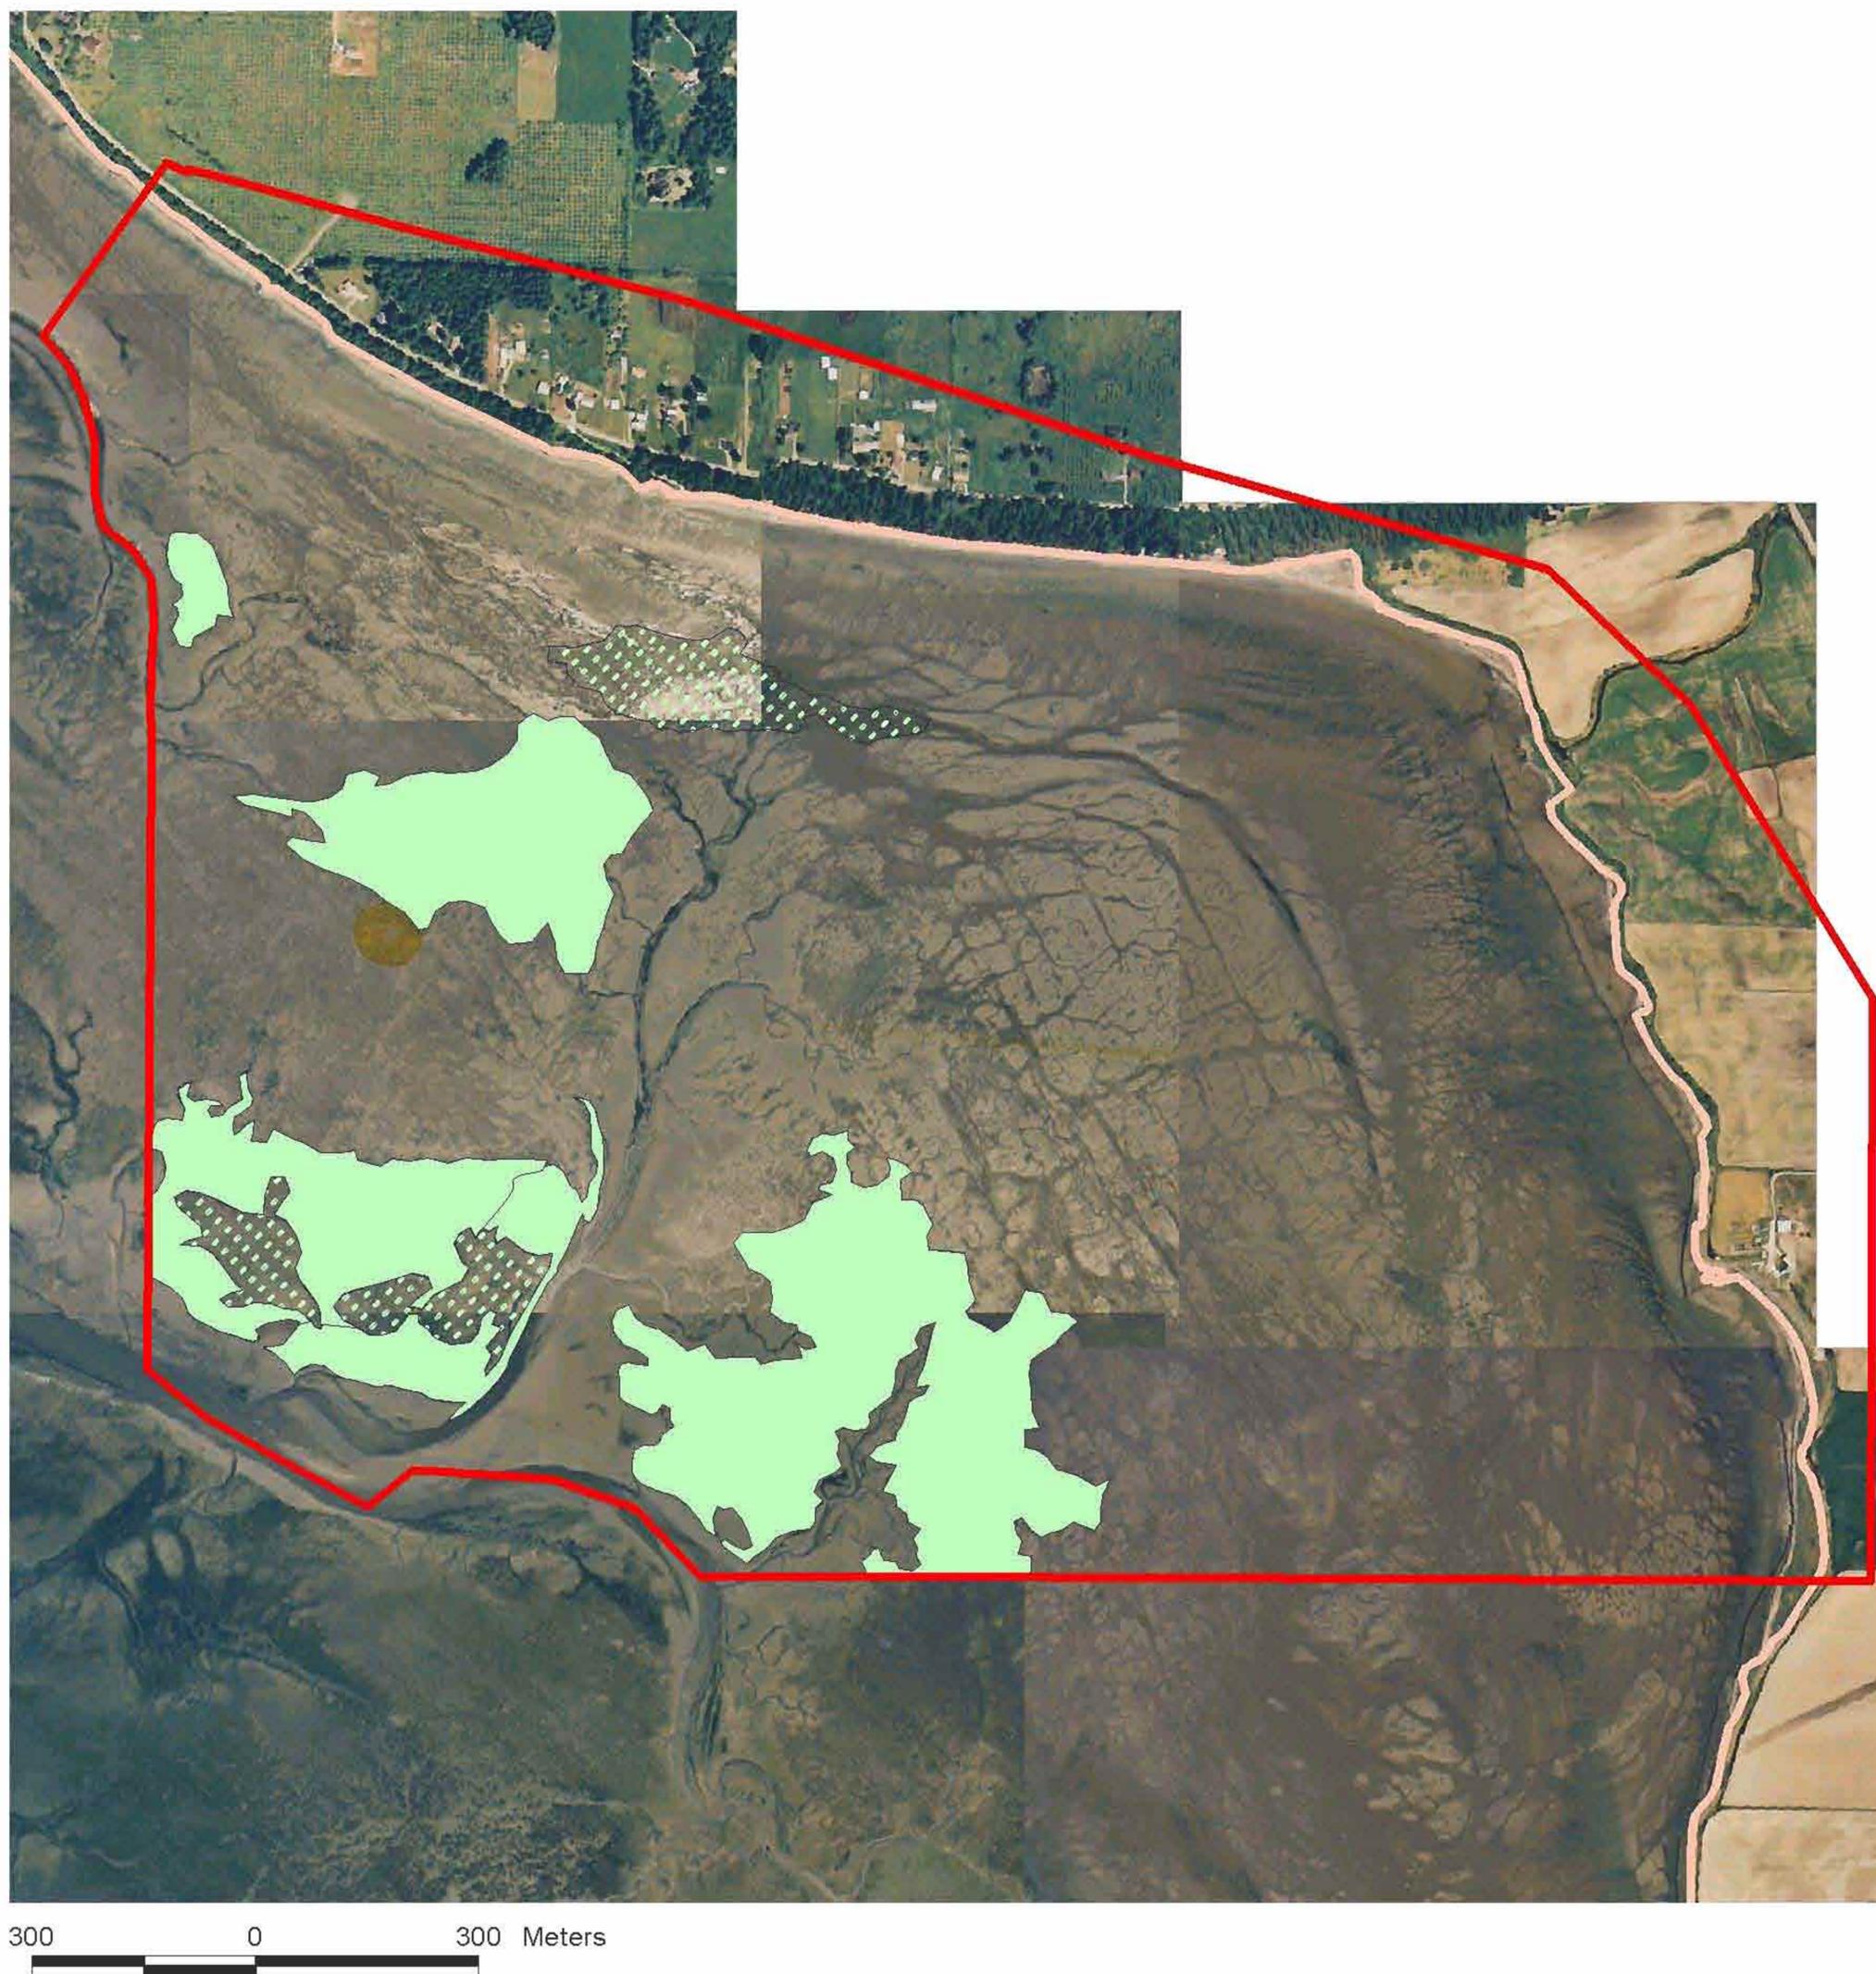
**Figure 13. Continuous eelgrass cover (in solid fill) and sparse eelgrass cover (in stipple pattern) in Northeast area of interest in Padilla Bay, Washington as delineated on true color aerial photographs taken on June 3, 1989.**

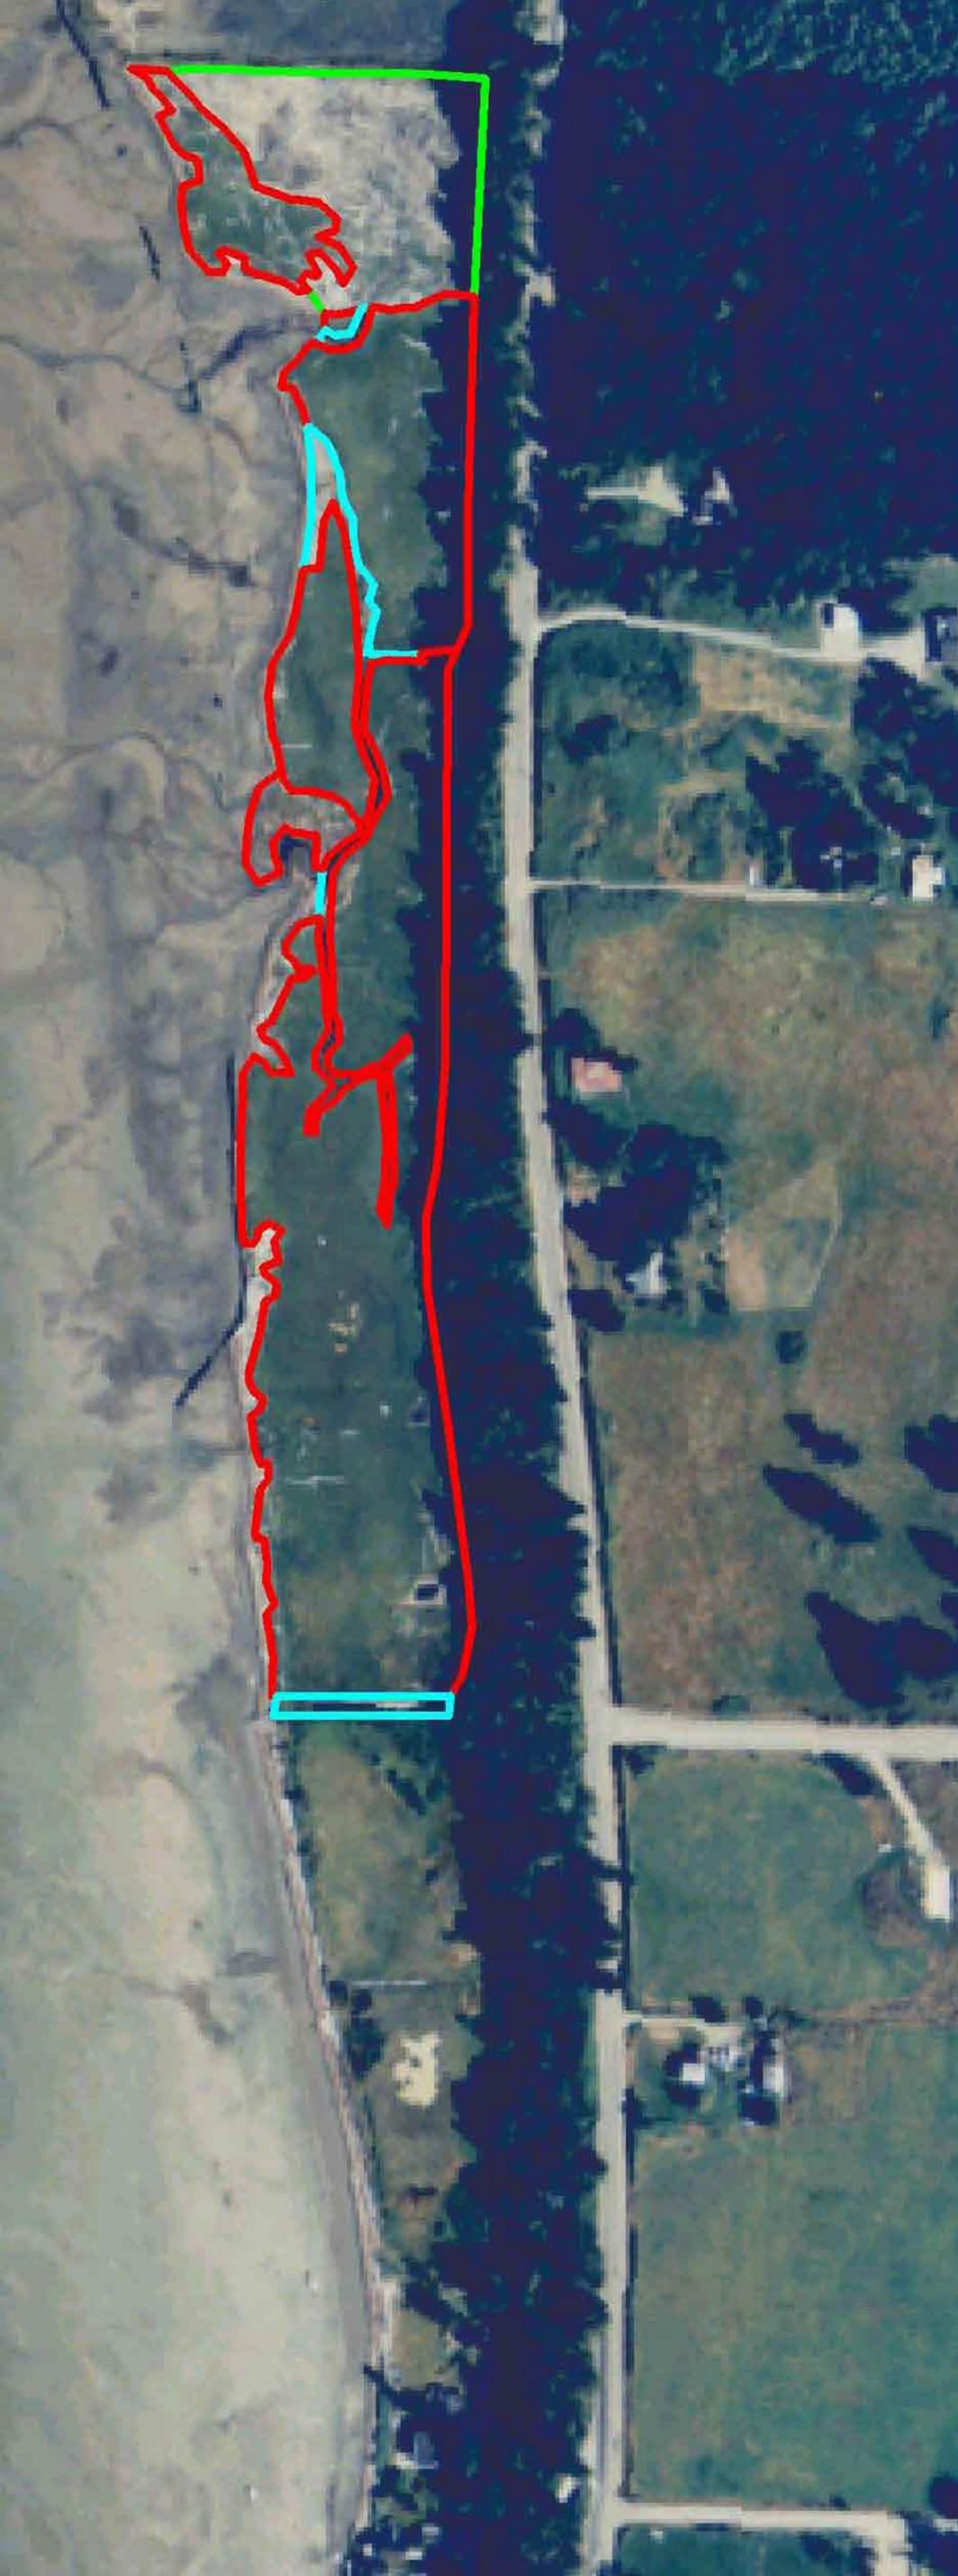
Sullivan Marsh 1992

**Figure 18. Native saltmarsh and log piles in Sullivan-Minor marsh, Padilla Bay, Washington as delineated on true color aerial photographs taken on July 30, 1992.**

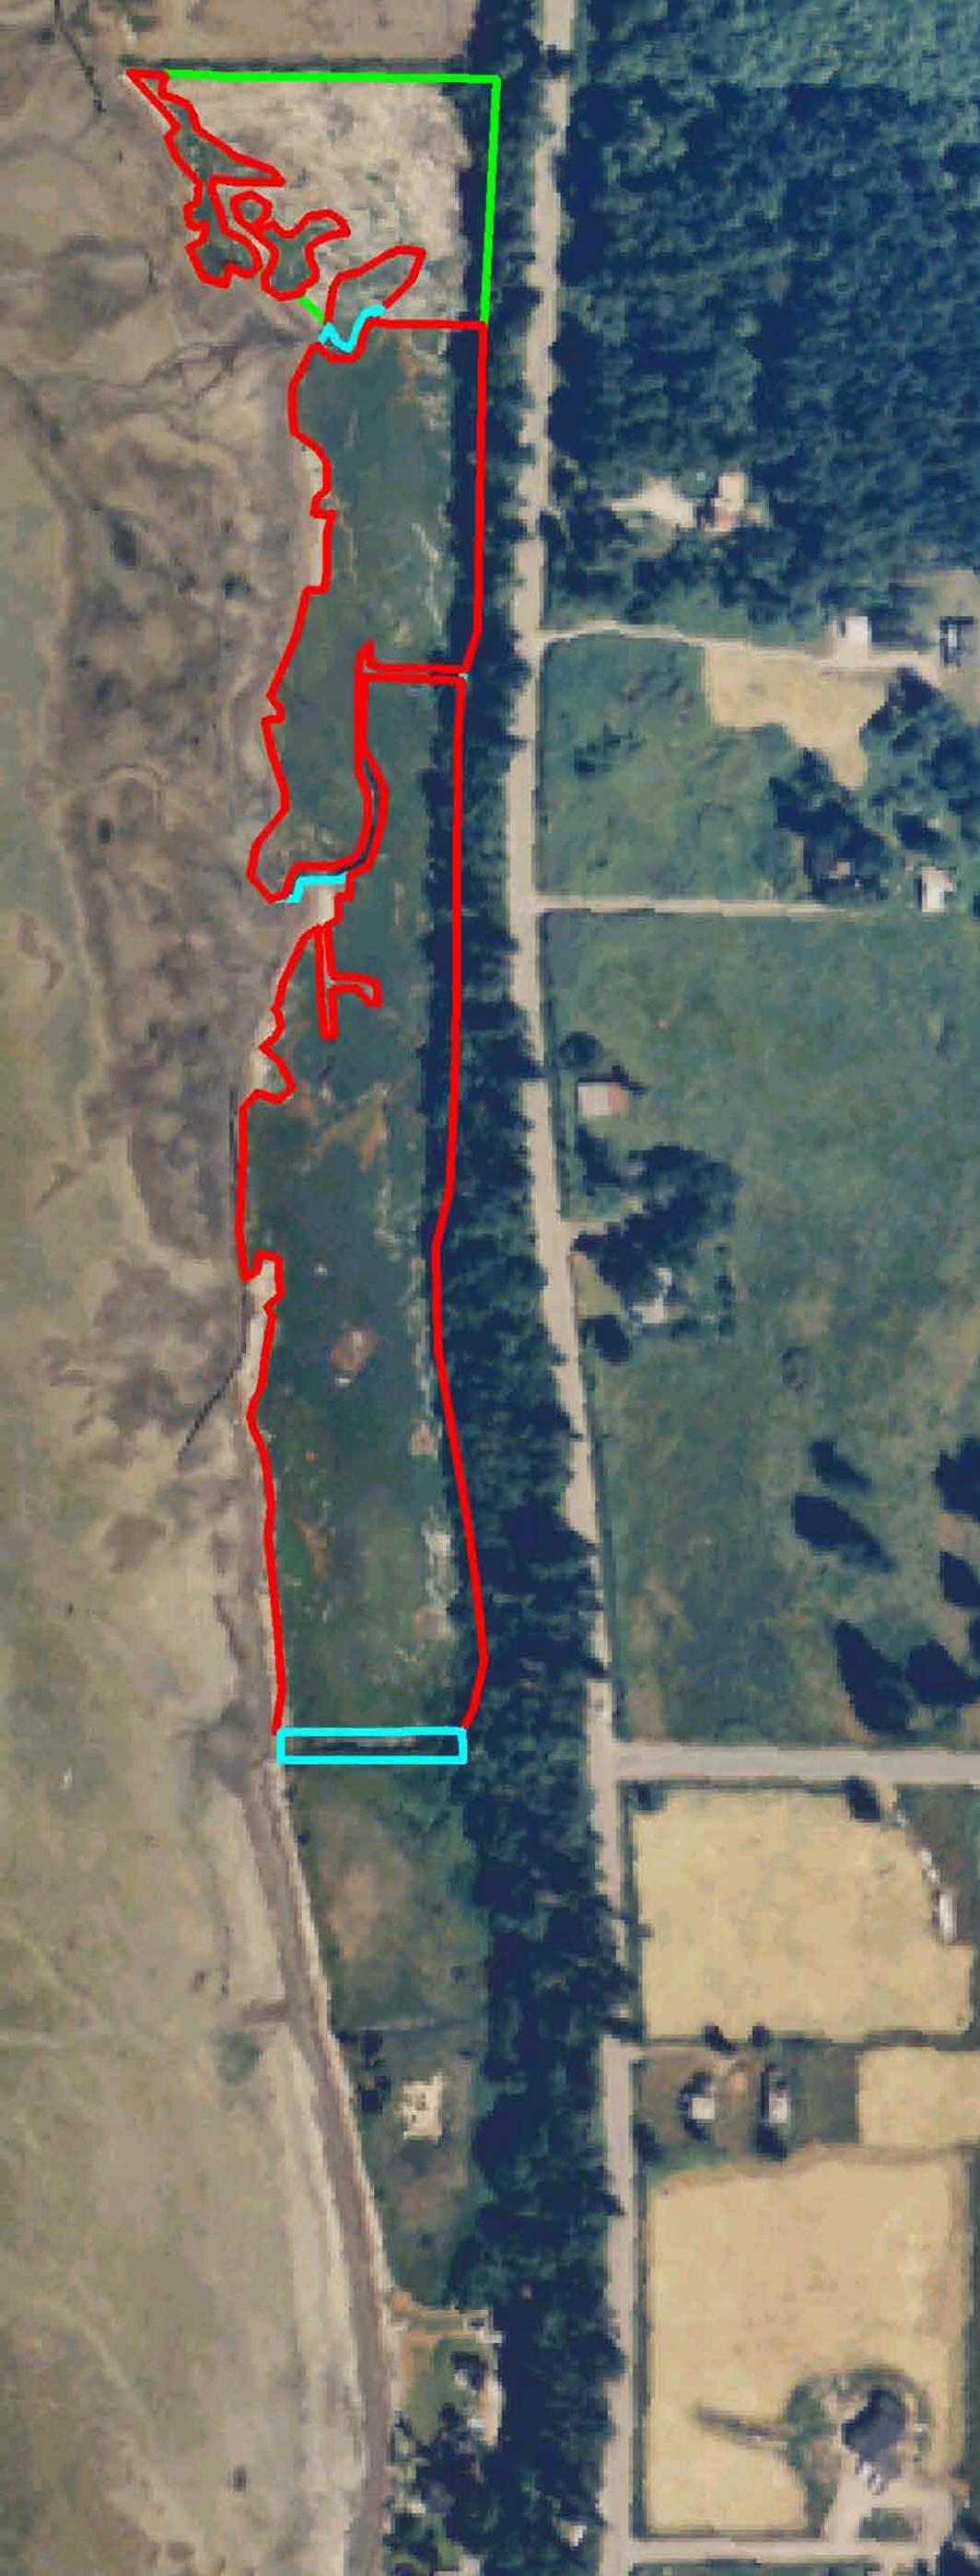
## Sullivan Marsh 1996

**Figure 19. Native saltmarsh and log piles in Sullivan-Minor marsh, Padilla Bay, Washington as delineated on true color aerial photographs taken on July 30, 1996.**

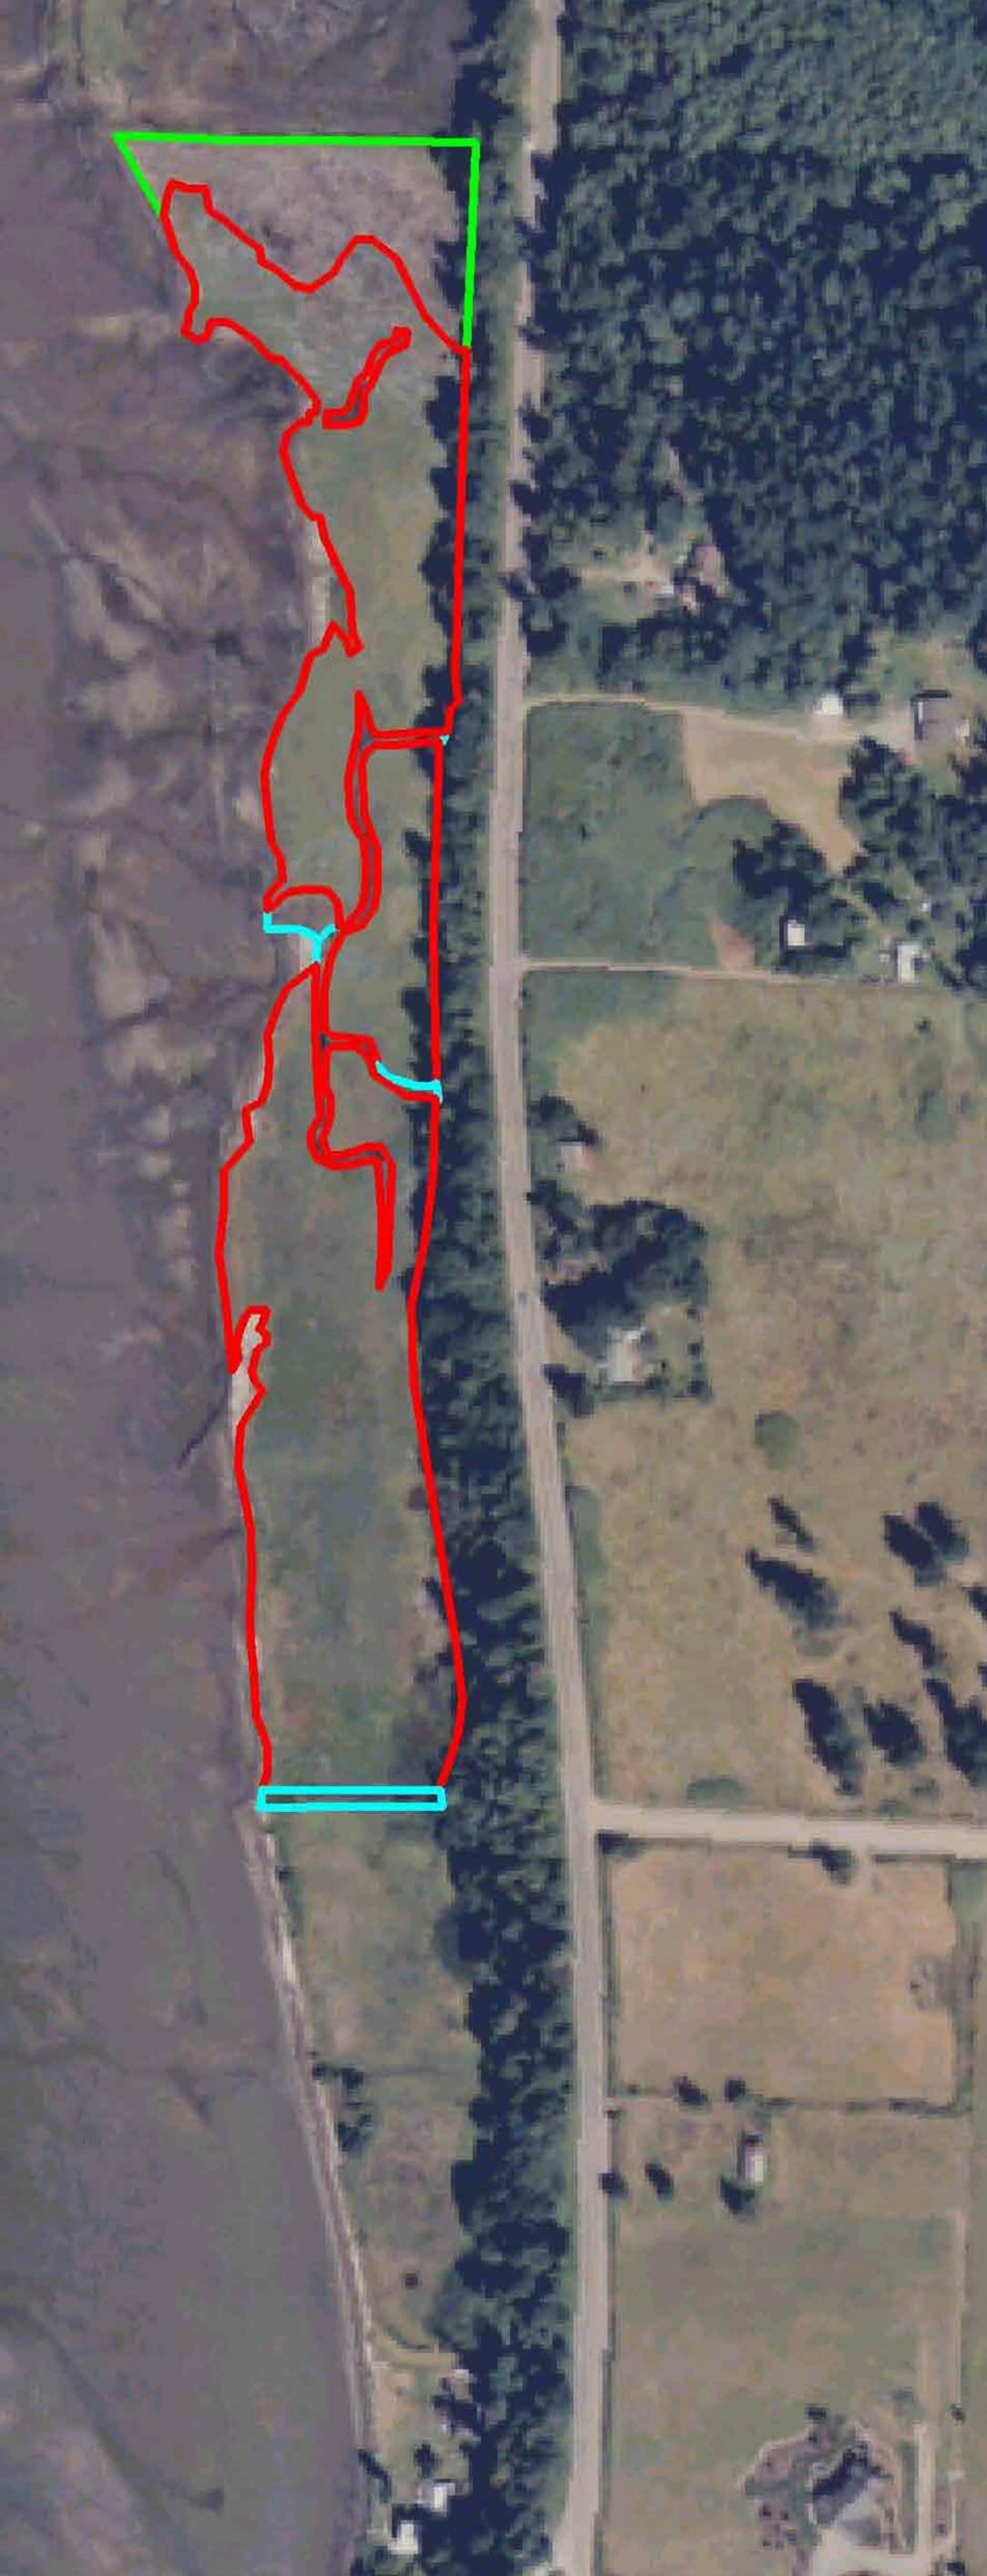
## Sullivan Marsh 2000

**Figure 20. Native saltmarsh and log piles in Sullivan-Minor marsh, Padilla Bay, Washington as delineated on true color aerial photographs taken on July 30, 2000.**

Figure 20. Native saltmarsh and log piles in Sullivan-Minor marsh, Padilla Bay, Washington as delineated on true color aerial photographs taken on July 30, 2000.

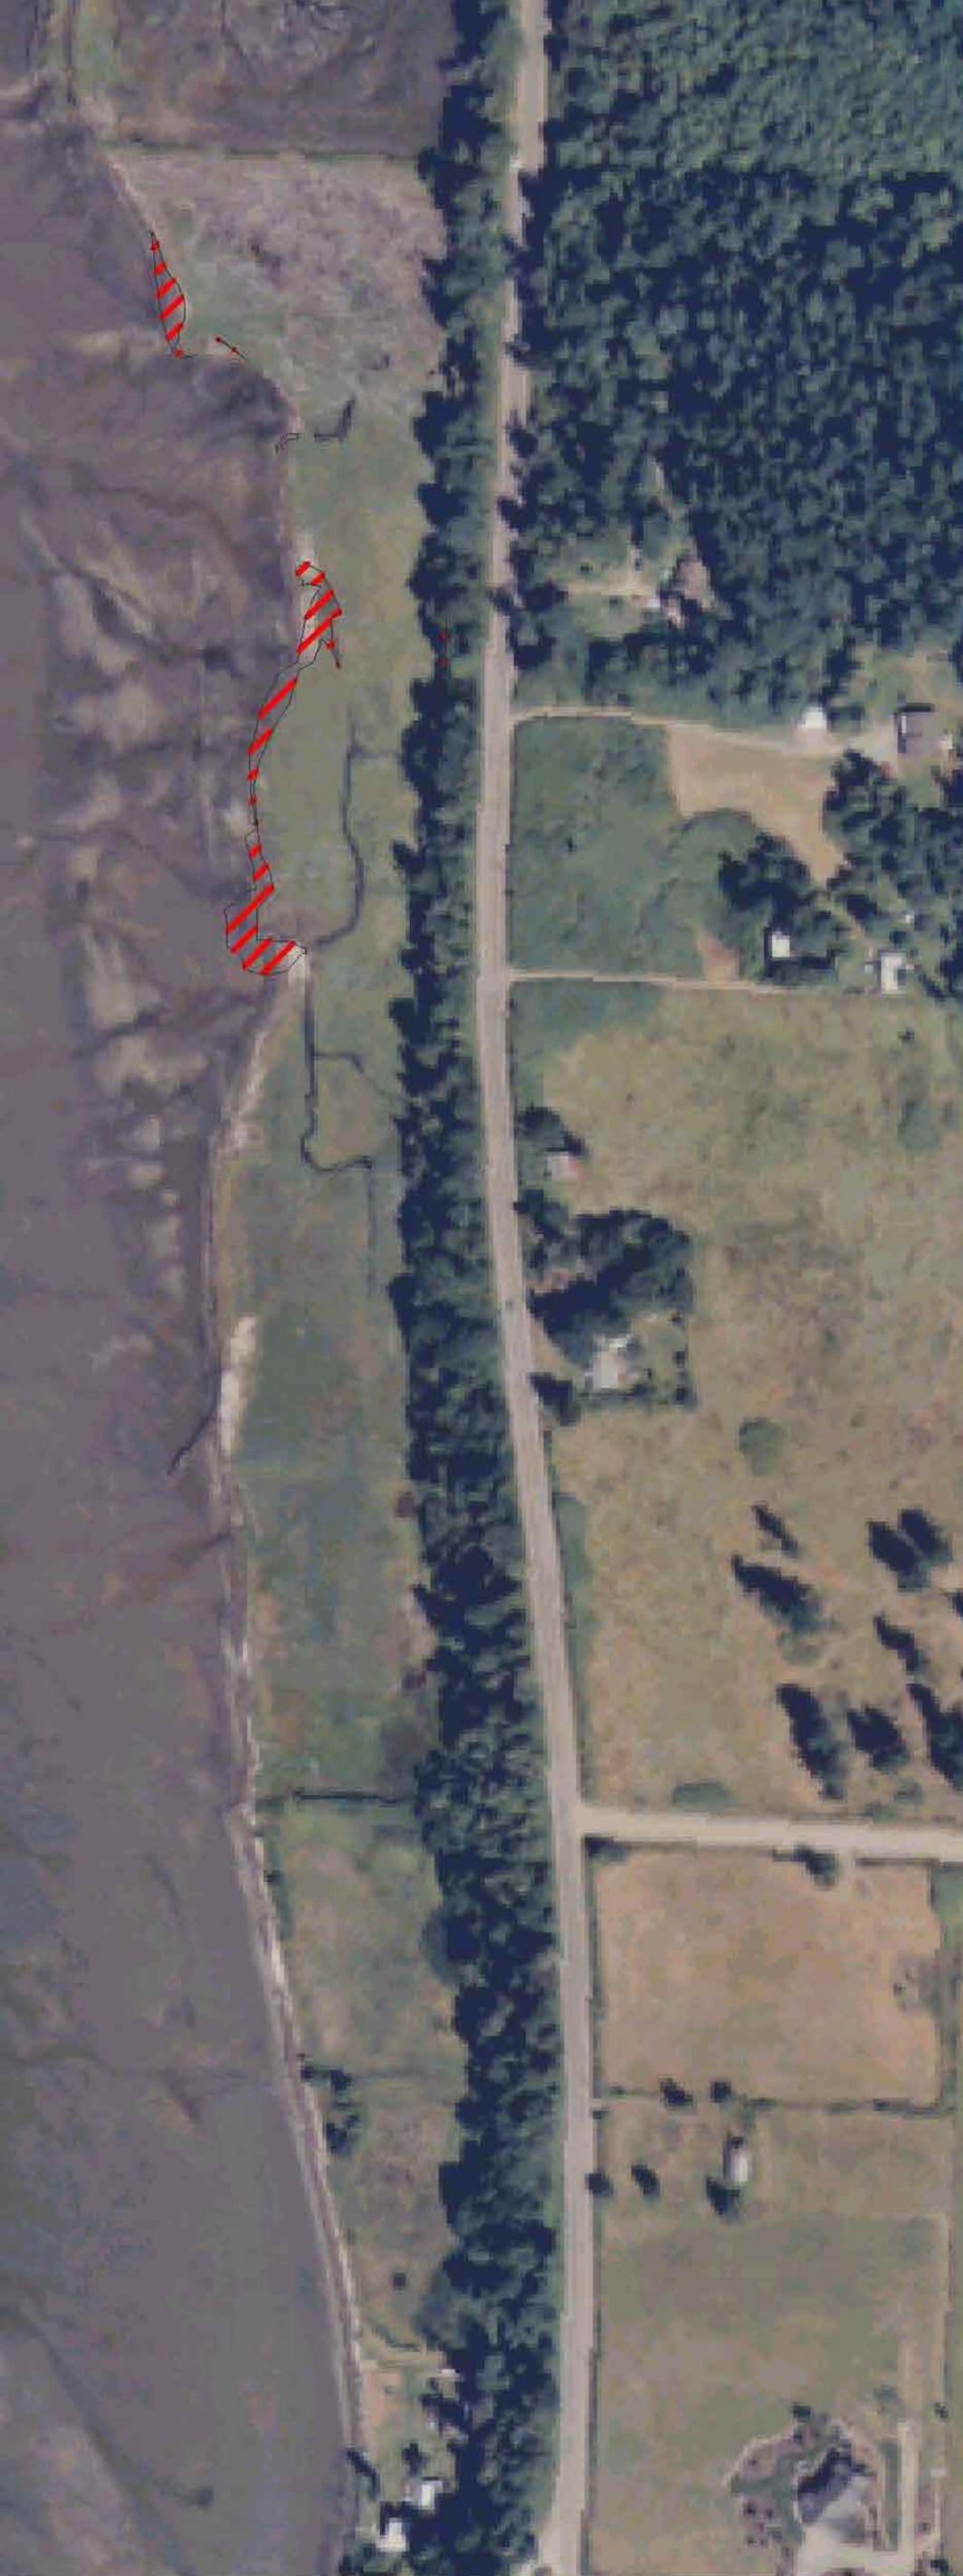
Change  
1989 to 2000

Figure 21. Area of salt marsh in Sullivan-Minor marsh, Padilla Bay, Washington that was lost between 1989 and 2000; displayed on an aerial photo taken on July 30, 2000.
